Observed rock mass degradation and resulting slope instability

M. Huisman

H.R.G.K. Hack

J.D. Nieuwenhuis

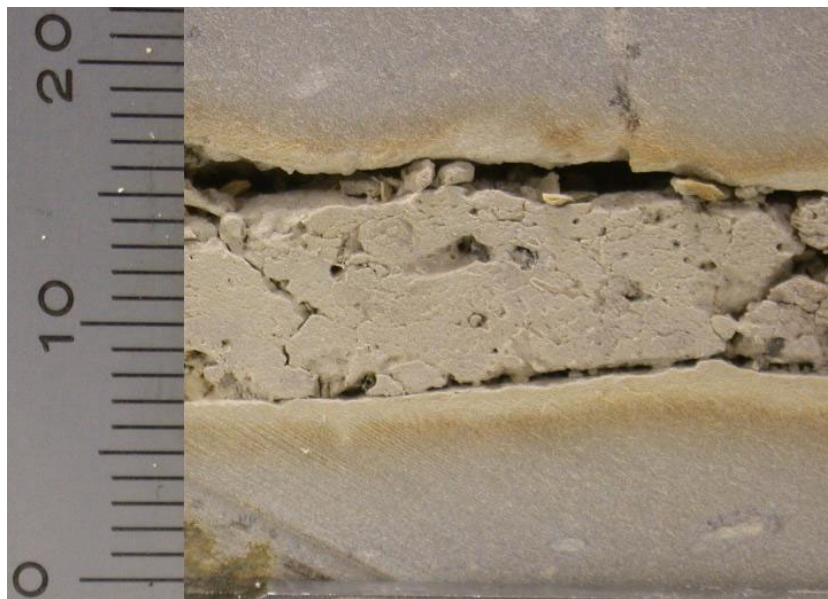
In 1991, the bedding planes were found to contain some clay infill (Cindarto, 1992). This was at the time no more than a thin dusting on the bedding plane surface, and thought to result from weathering as the bedding planes often contain some minor contents of clay. In 2002 parts of the outcropping bedding planes, and especially the bedding plane which acted as sliding plane in 1991, were found to contain a significantly thicker slightly plastic layer of approximately 8mm (see Figure 1).

Figure 1 - The plastic layer developed on the bedding plane in cross-section (shear box sample, 2003; scale in mm)

Material analysis using XRF/XRD testing indicated a montmorillonite content in this layer of approximately 3% by volume, which explains the plastic behaviour. Furthermore, the presence of even such small amounts of montmorillonite suggests that the layer is vulnerable to further weathering and weakening (Kühnel, 2002). The total clay content including non-swelling clays is approximately 14%. Apart from the plastic layer, the discontinuity walls were weathered to a depth of about 1mm (see Figure 1). Block samples incorporating this plastic layer were taken for shear box testing in 2003, to compare with the results of the 1991 tests.
