Flood Control 2015

Dyke quality assessment by remote sensing

Pilot project: RSDYK2008

Test sites in Reeuwijk – Zuid Holland

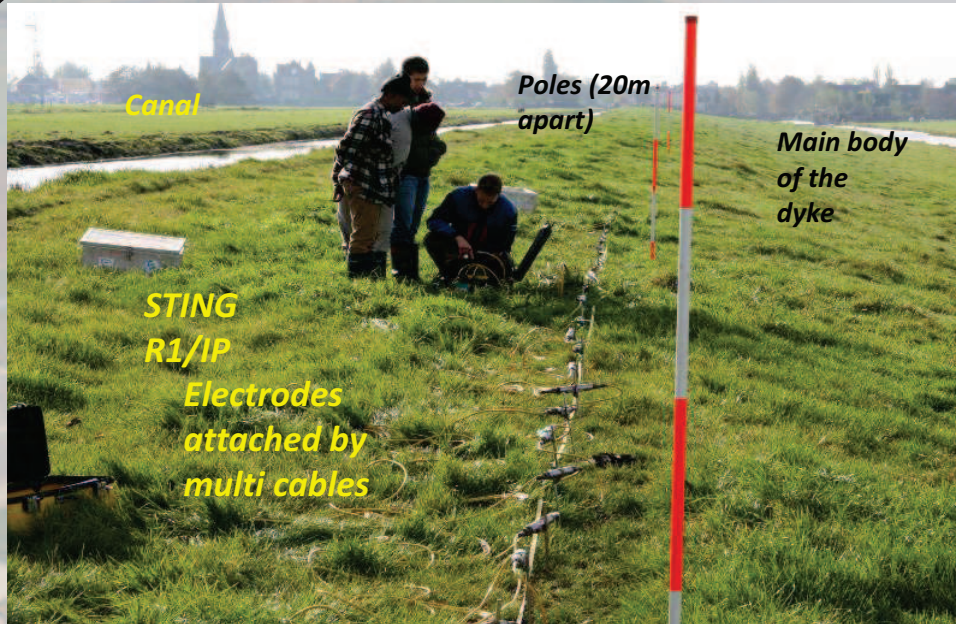
A 2-D electrical imaging survey on the Tempeldijk-North

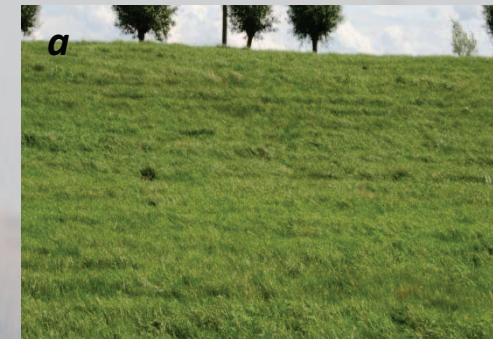
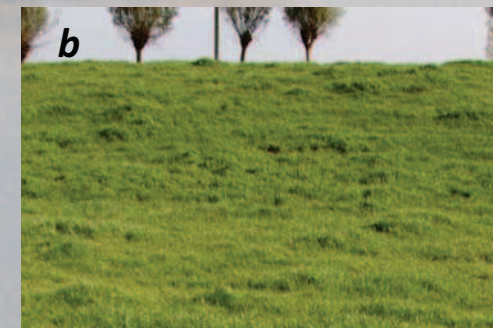
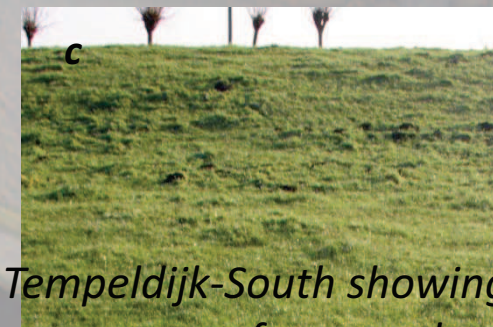
Visual images of Tempeldijk-South showing the difference in the apparent surface roughness in (a) August 15, 2007, (b) October 31, 2007 and (c) December 13, 2007 field campaigns.

- Visual images showed differences in vegetation cover at locations where excess water is likely present.
- The gamma ray survey shows a pattern that is likely related to the real subsurface structure, but further investigations are required to determine the exact nature of this relation.

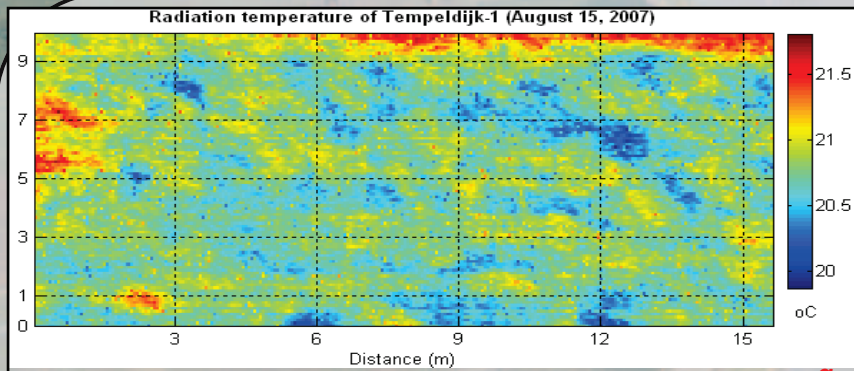
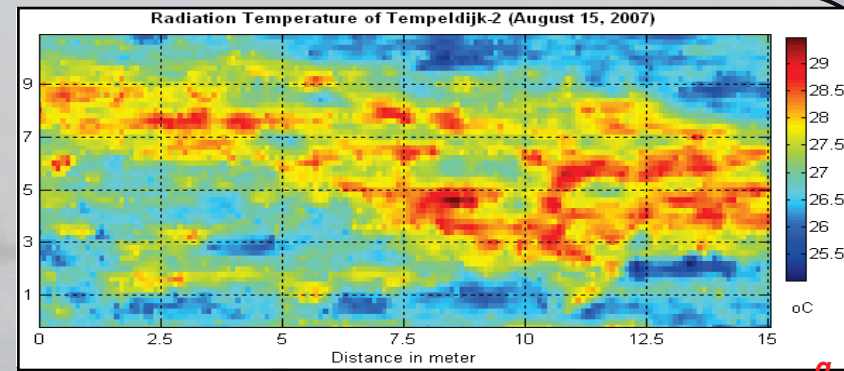
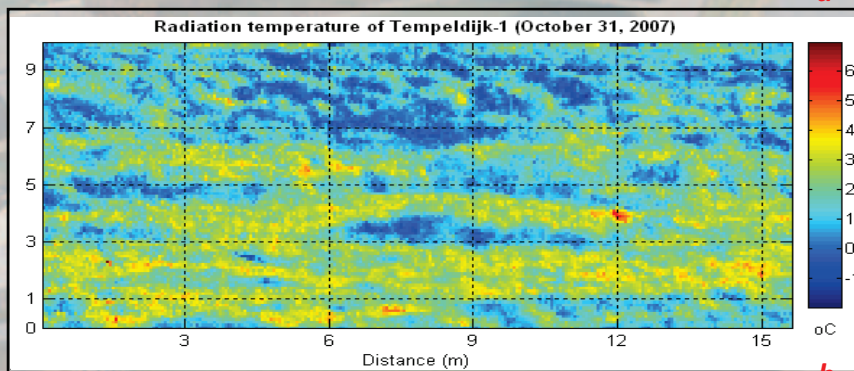
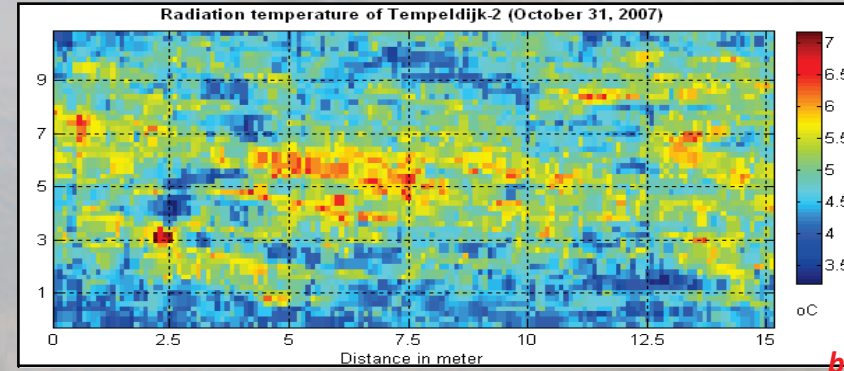
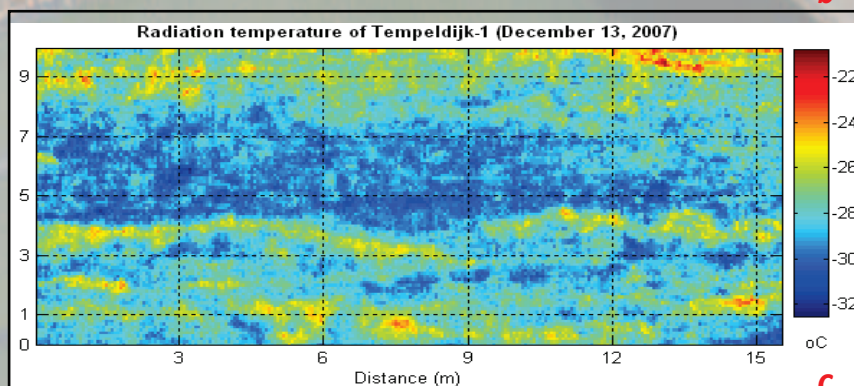
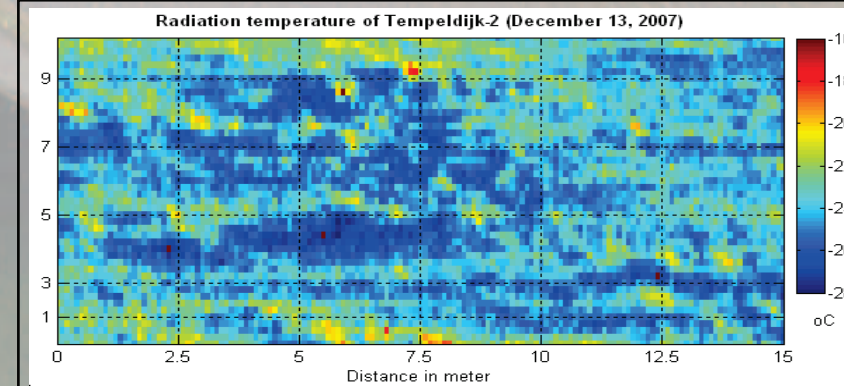
Tempeldijk - temperature

- The thermal infrared images of Tempeldijk-South showed a layered structure which is reflecting the subsurface structure of the dyke. The layered structure was detectable likely because excess water was present in some of the layers.

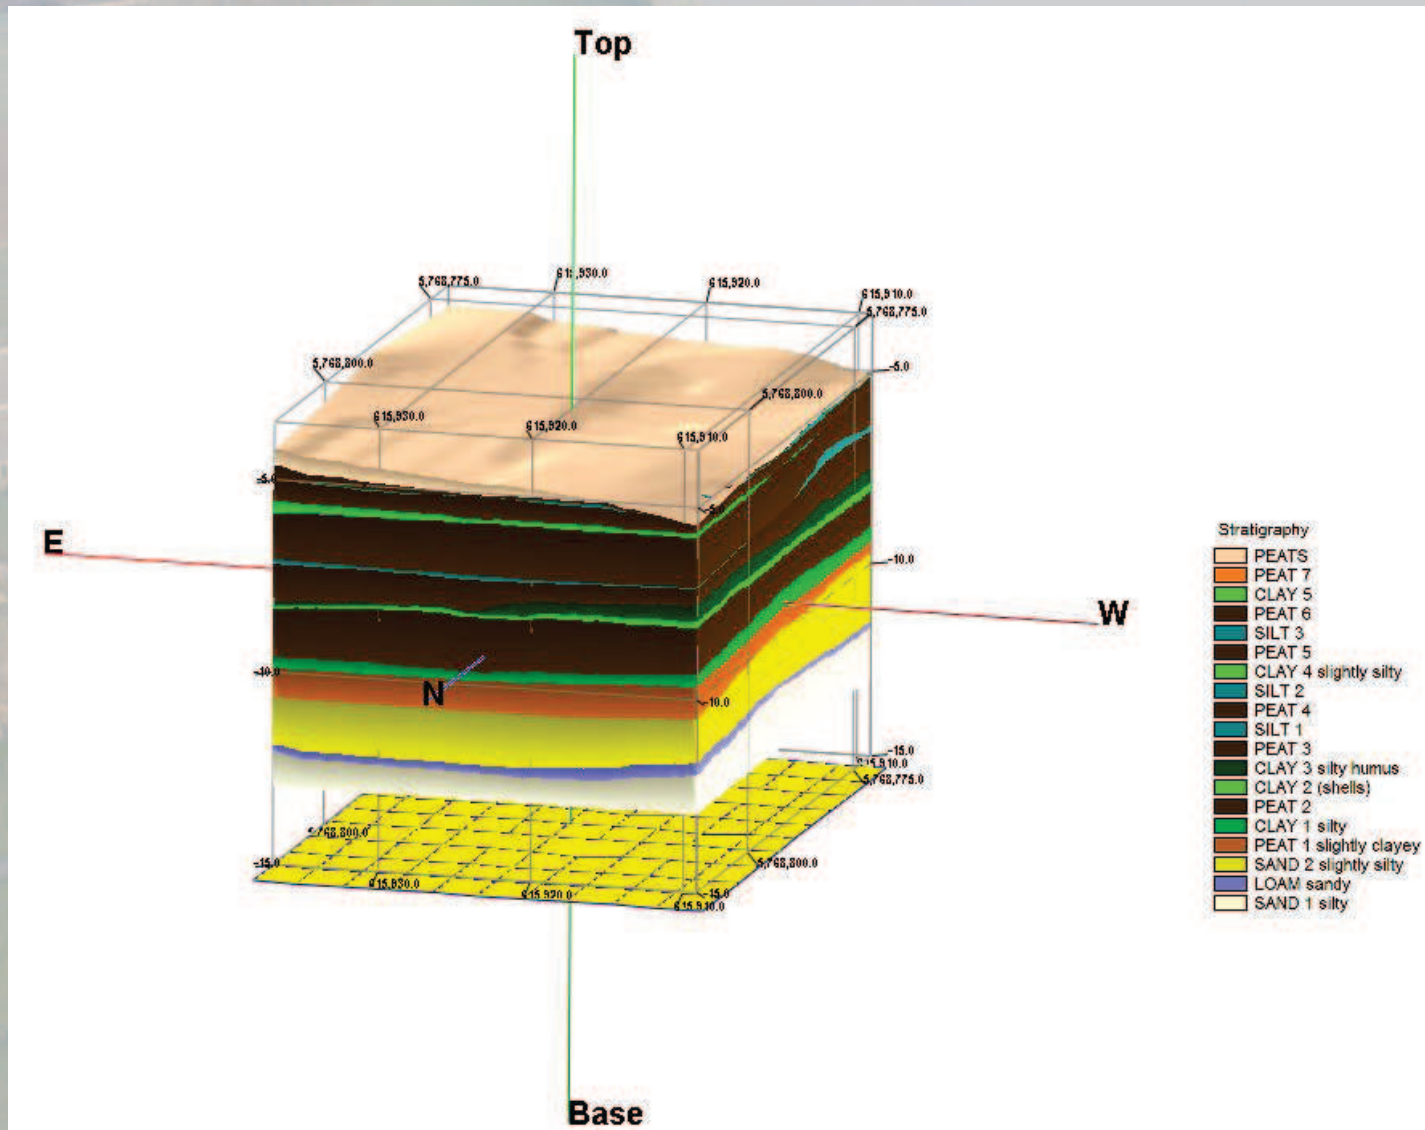
Subsurface – Tempeldijk - South

- All surface and subsurface investigations the Tempeldijk-South surface and subsurface structure are more irregular which are due to or indicate “problems” such as “kwel” and subsidence.
