RSDYK

Dyke quality assessment by
remote sensing
and
geological information

Robert Hack

15 Oct 2009 Reeuwijk - Hack

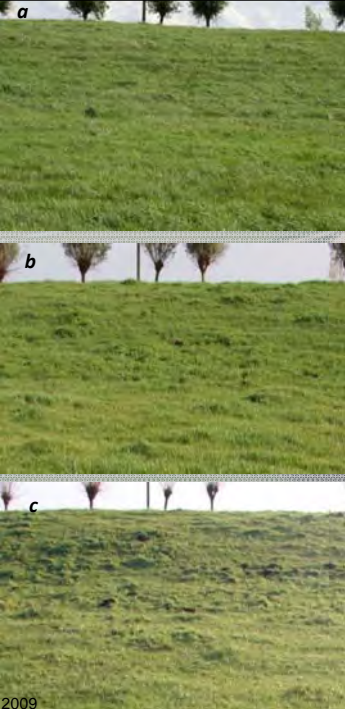
Tempeldijk-south visual light

Visual images of Tempeldijk-South showing the difference in the apparent surface roughness in (a) August 15, 2007, (b) October 31, 2007 and (c) December 13, 2007
