Medium Tank Mark A

Whippet

Medium A Whippet

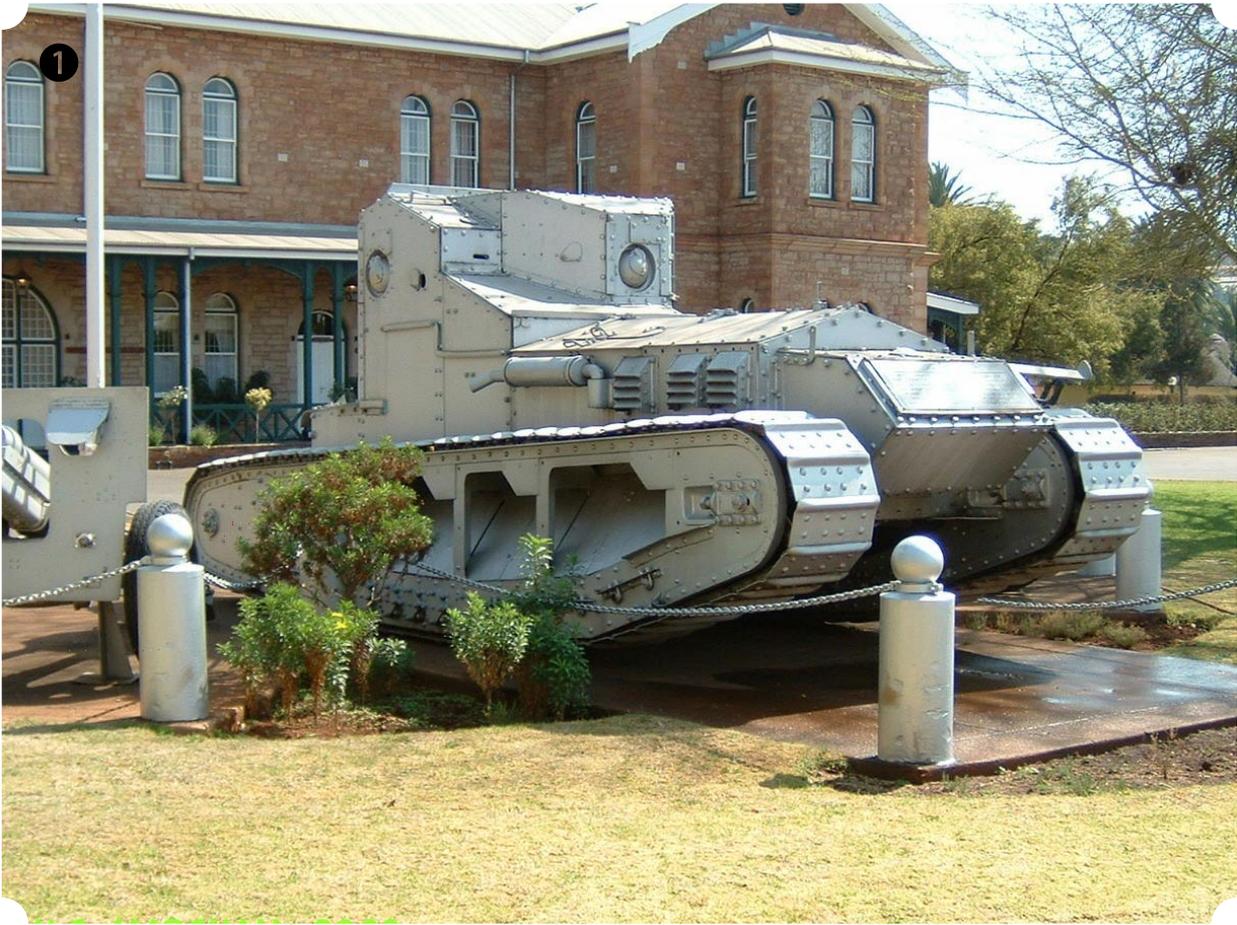
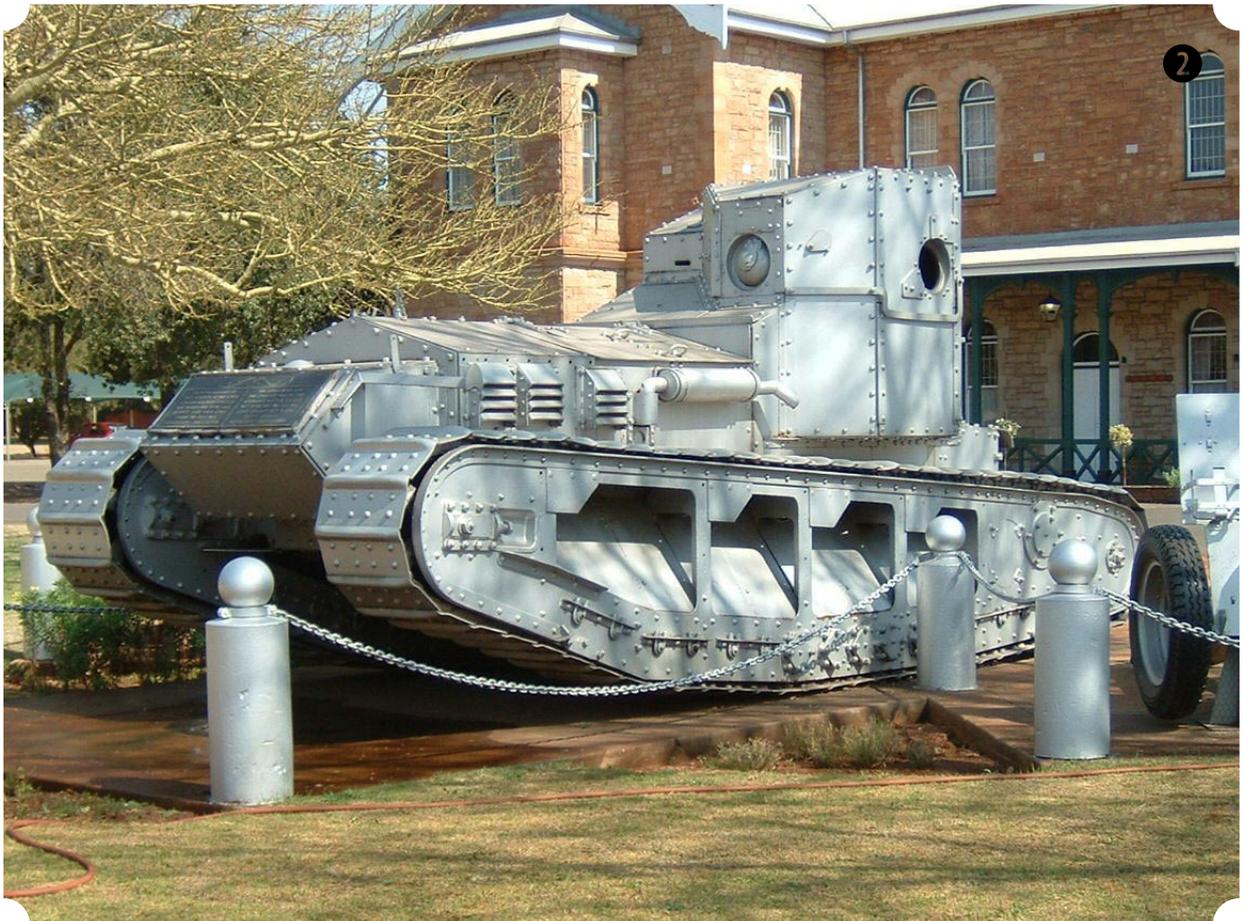
Right rear

From behind, the height of the cab is more apparent than from the front. This view also shows the remaining two machine gun mountings, though they have also been replaced by the non-standard type, and the one in the rear door has fallen into the tank (as can be seen in picture 51 on page 57).

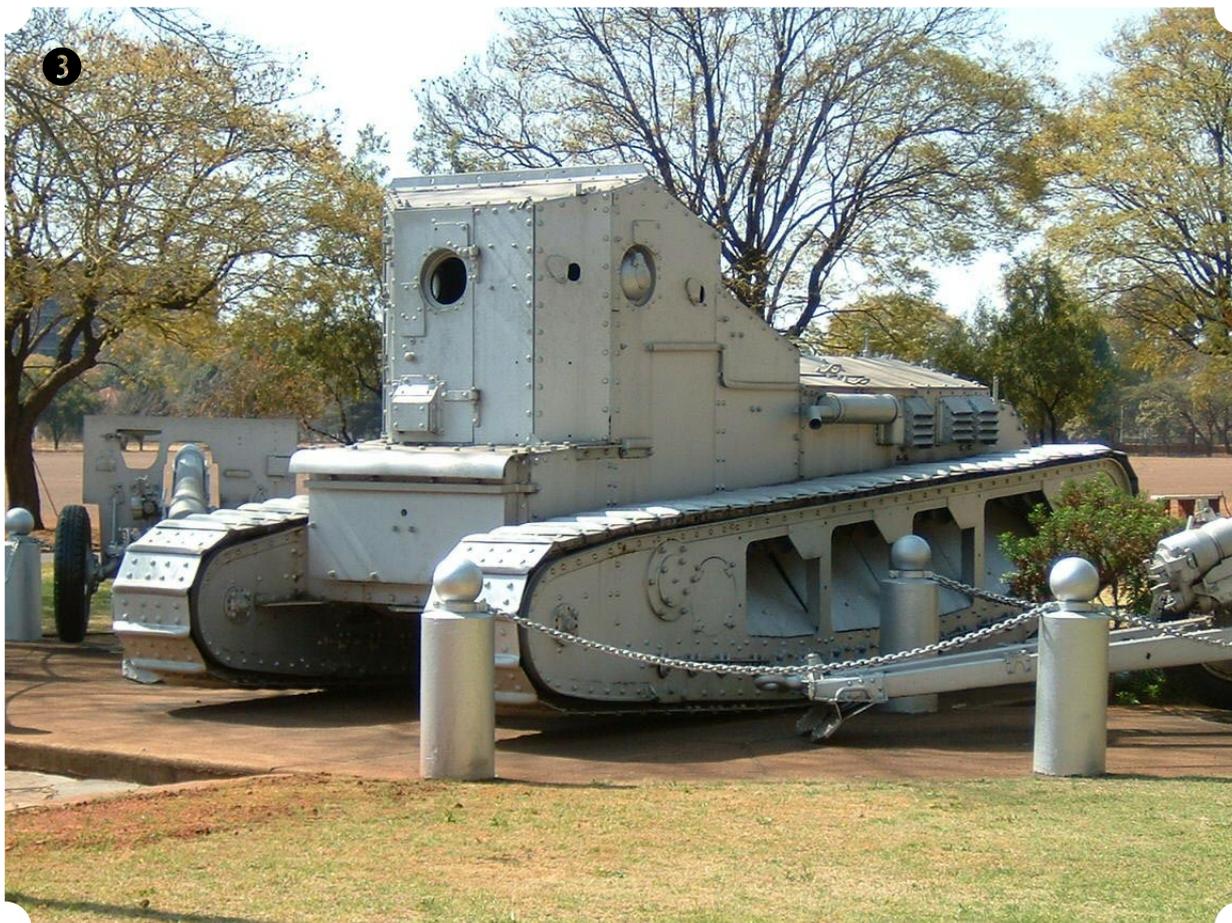
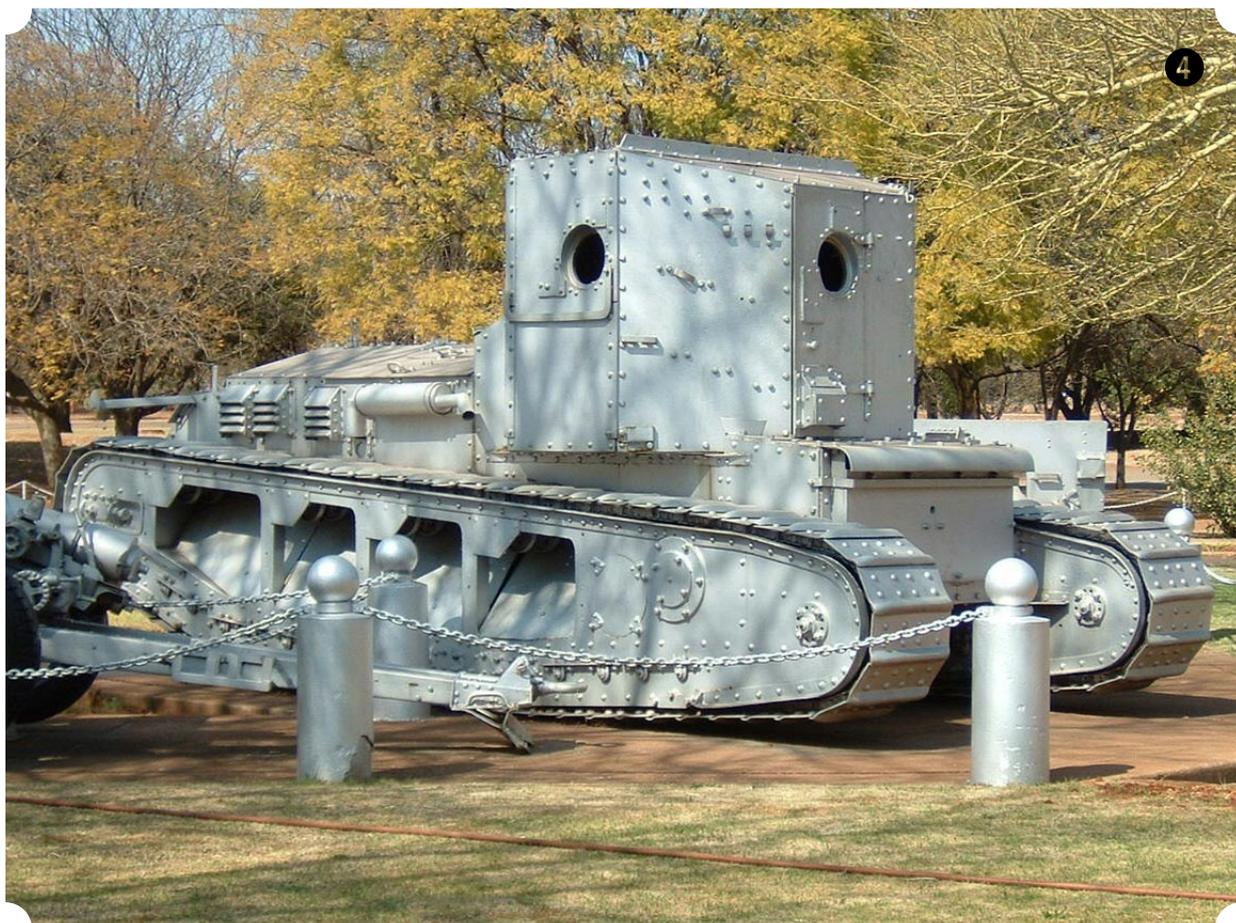
Cab front left

This photo of the left front corner of the crew compartment, this time of the Whippet in Bovington Tank Museum. It clearly shows the rivetted construction of the tank, with even a few external strips of angle iron being used to hold plates together. The horizontal metal bar, held by a bolt rather than a rivet at each end, is a bracket for carrying track grousers (wooden blocks, reinforced with metal strips, that could be fitted to the track to increase traction). Unfortunately, no grousers are present on this tank, and some of the racks are gone as well.

Also note the different style of machine gun mounts, which will be shown in more detail on later pages.

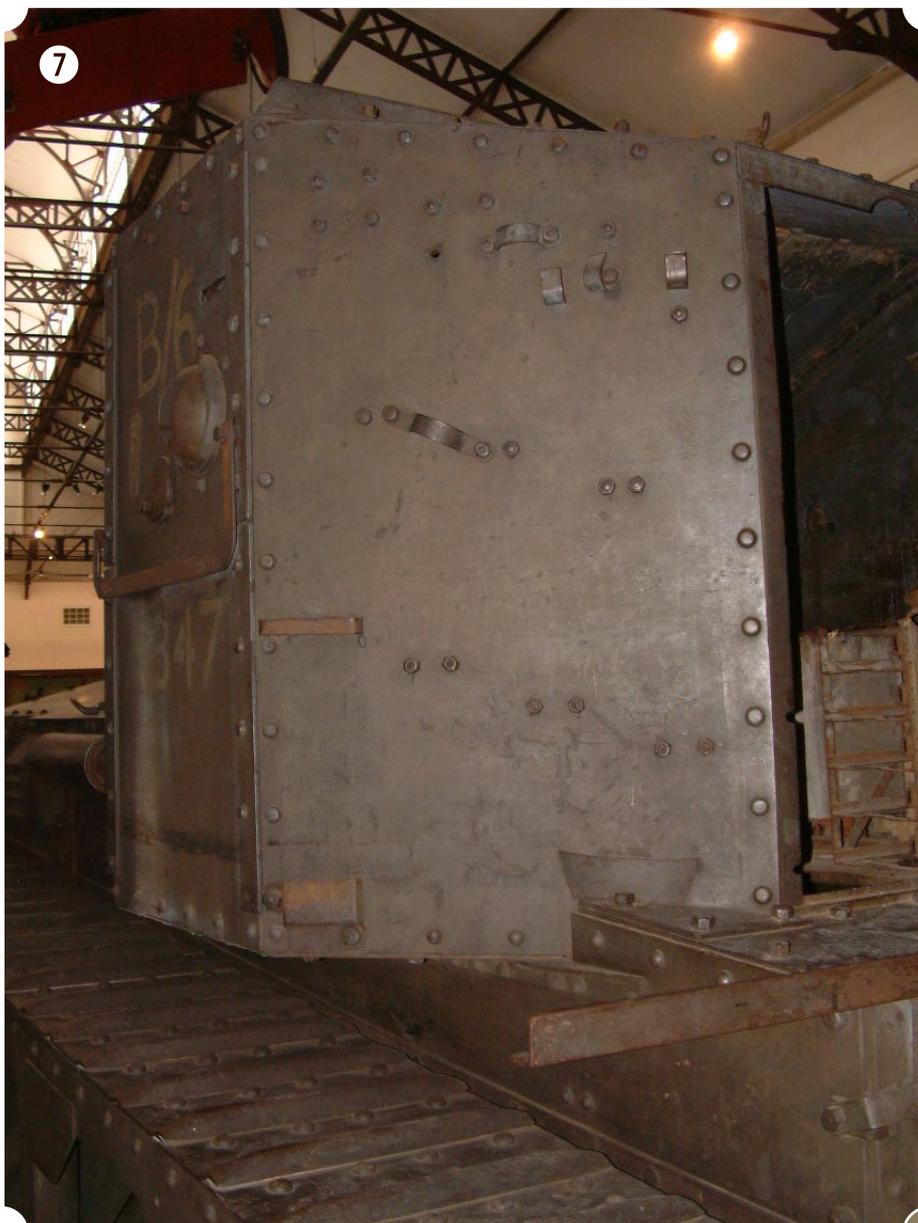
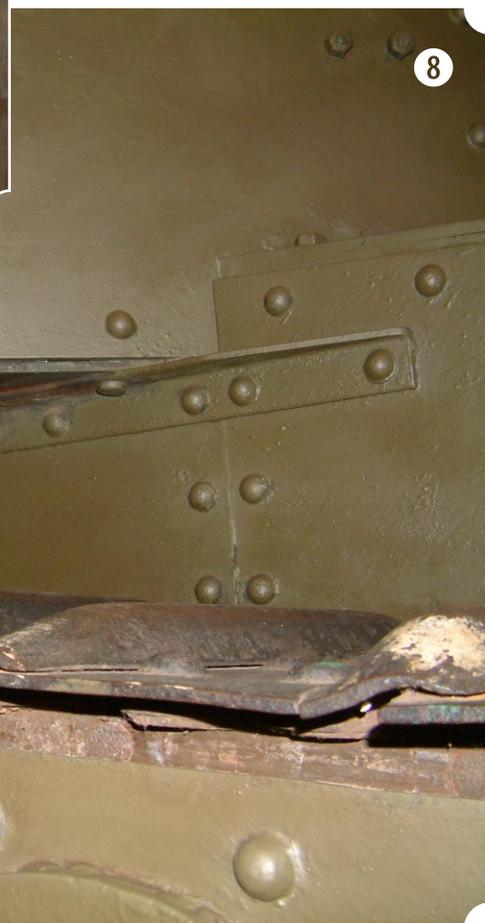
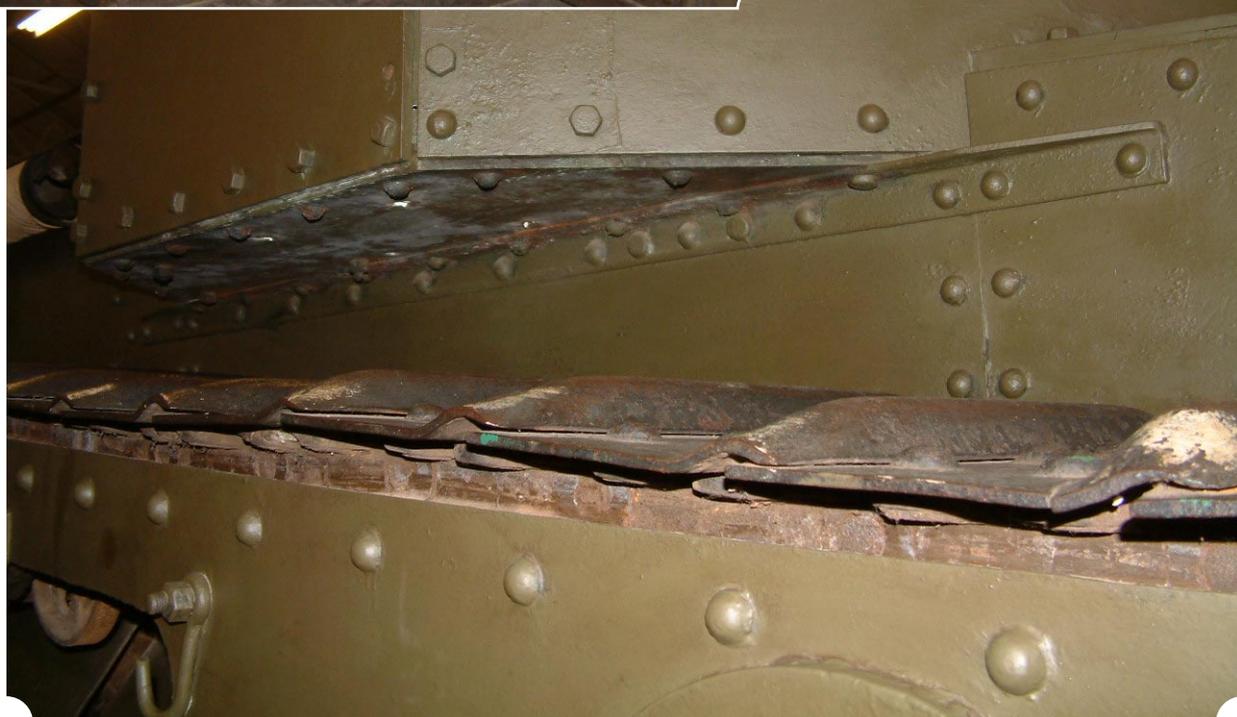
Cab rear

The rear of the cab is equipped with a door to let the crew enter and leave the tank. A machine gun mount was installed in the door, which had a vent at the bottom, covered by an armoured box. Pages 52 through 55 have more details of both.

As before, the gun mount was replaced by a larger one on this South African tank, and both the associated vision slit and pistol port have been closed by plates riveted over them. Note that the new gun mounting was so much bigger than normal that the door's top hinge had to be shortened—it is normally the same size as the bottom one.

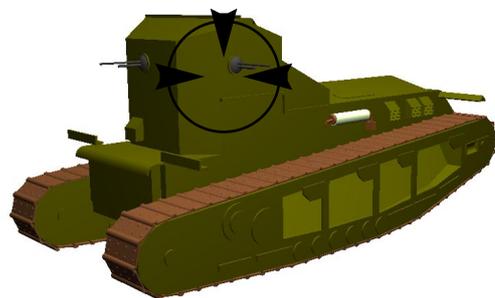
Cab side right

There is another machine gun mounting in the right-hand side, together with pistol ports to cover the area between the mountings.

The black lines painted on the vehicle in this photo are to simulate vision slits, in order to confuse German gunners. The vision slit for the machine gun mount has been incorporated in the black lines as well.

The rails on the cab side are once again for storing track grousers.

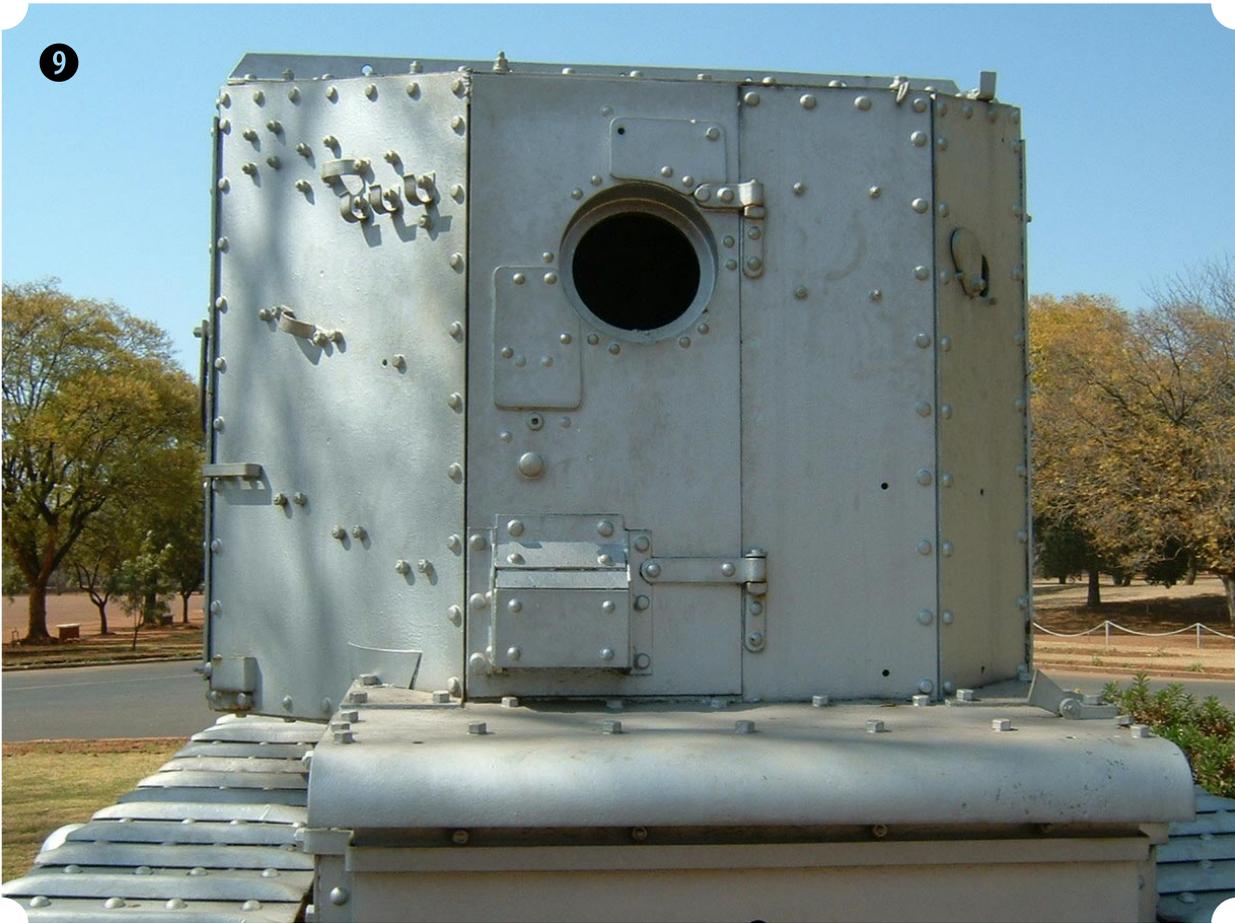
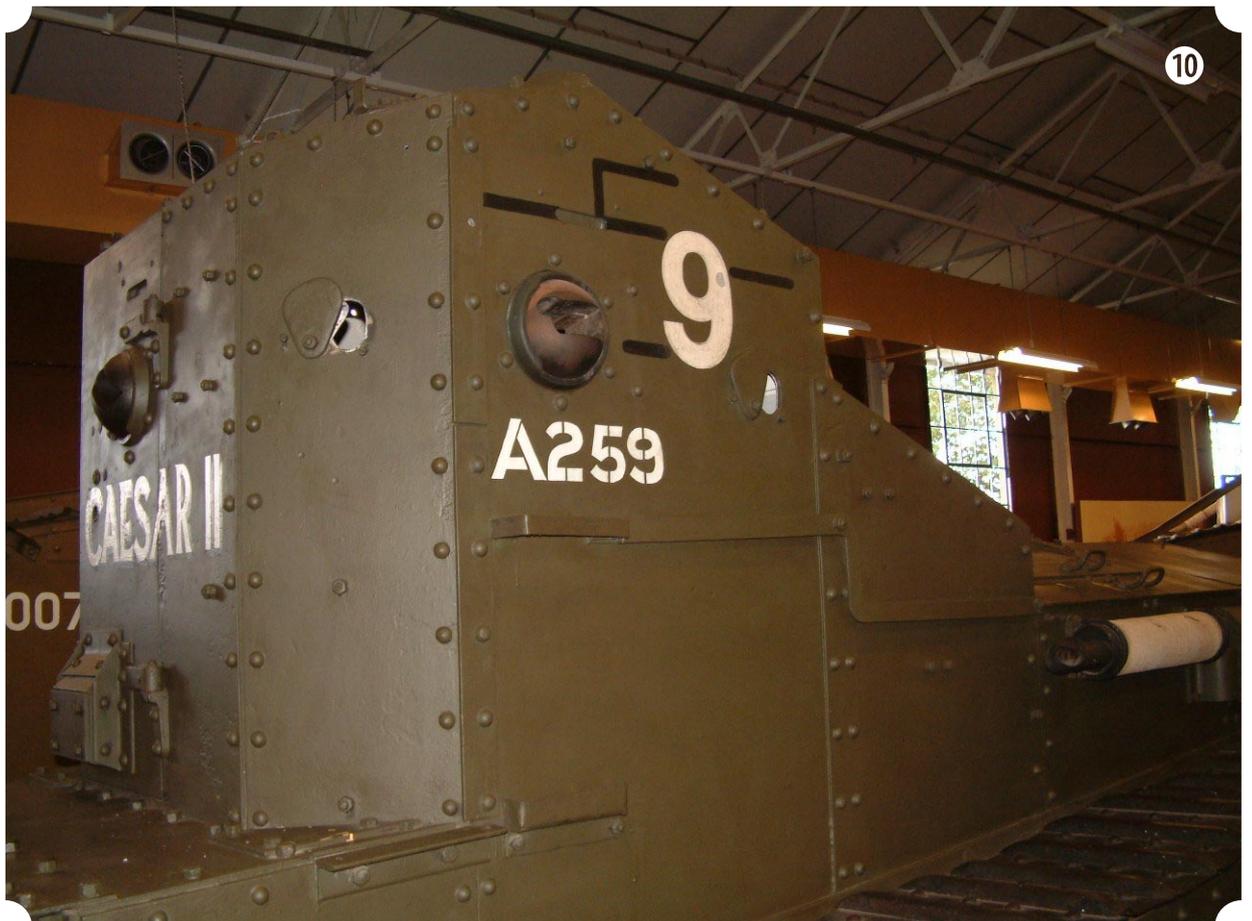
Battle damage

The Belgian Whippet has suffered quite extensive damage to the right rear of its cab, with the armour plate having been largely shattered by what looks like the impact of a large-caliber shell. This has not only caused a hole in the armour, but has also ripped some of the adjacent plates out of their normal positions.

As can be seen on pages 57 through 61, the interior does not seem to have suffered overly much from this damage, however—it appears mostly intact, although the impact cannot have been pleasant for the crew. The damage further shows why riveted construction is not ideal for a fighting vehicle: several rivets have snapped off as a result of the plate buckling under the impact, and they would have made lethal projectiles inside the tank.

The oval hole just to the right of the battle damage is one of the pistol ports. Its shutter was hinged in the small hole to its left, but was probably knocked off by the impact.

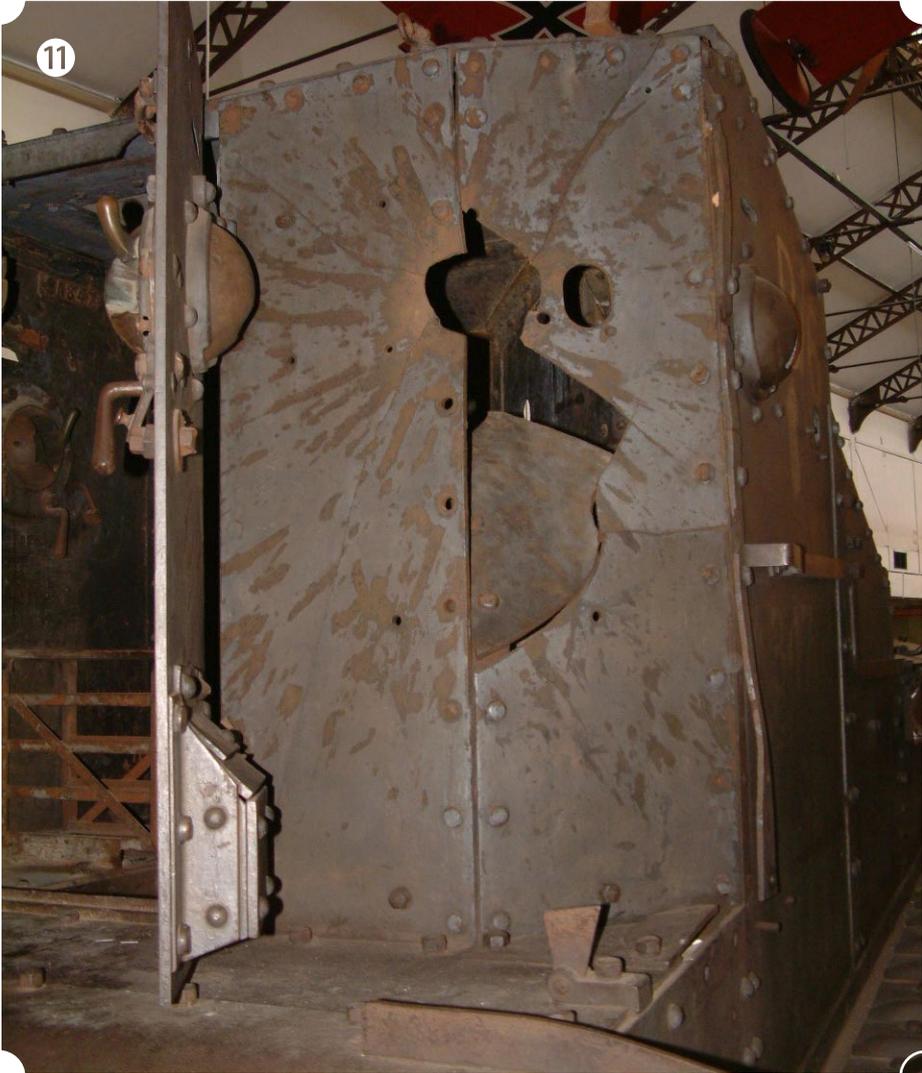
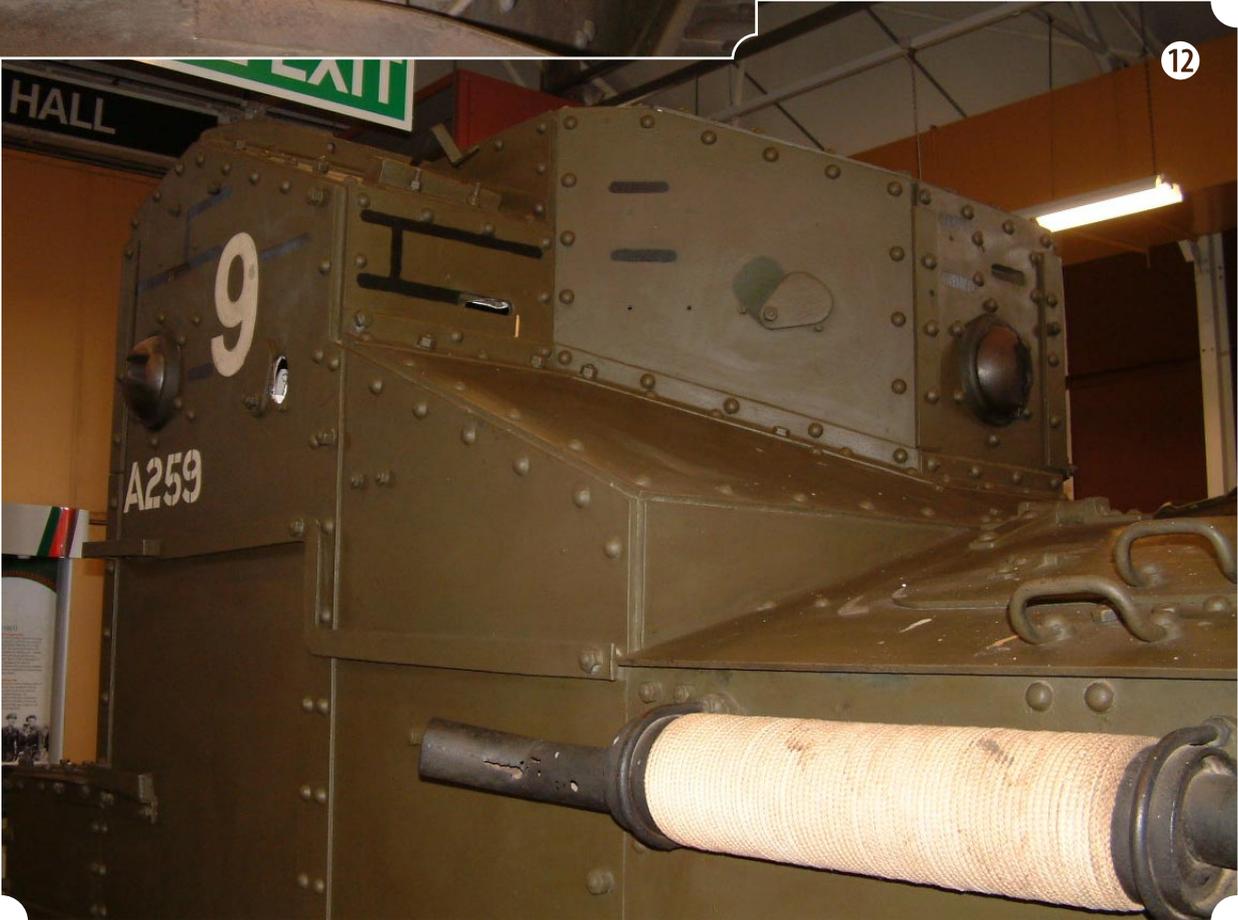
Cab front

The picture also provides a good view of the South African firing port, and note that once again, the vision slit above it has been closed with a metal plate. It appears a firing port has been installed in the roof over the driver's position (at left in the picture), which is not normally present on Whippets.

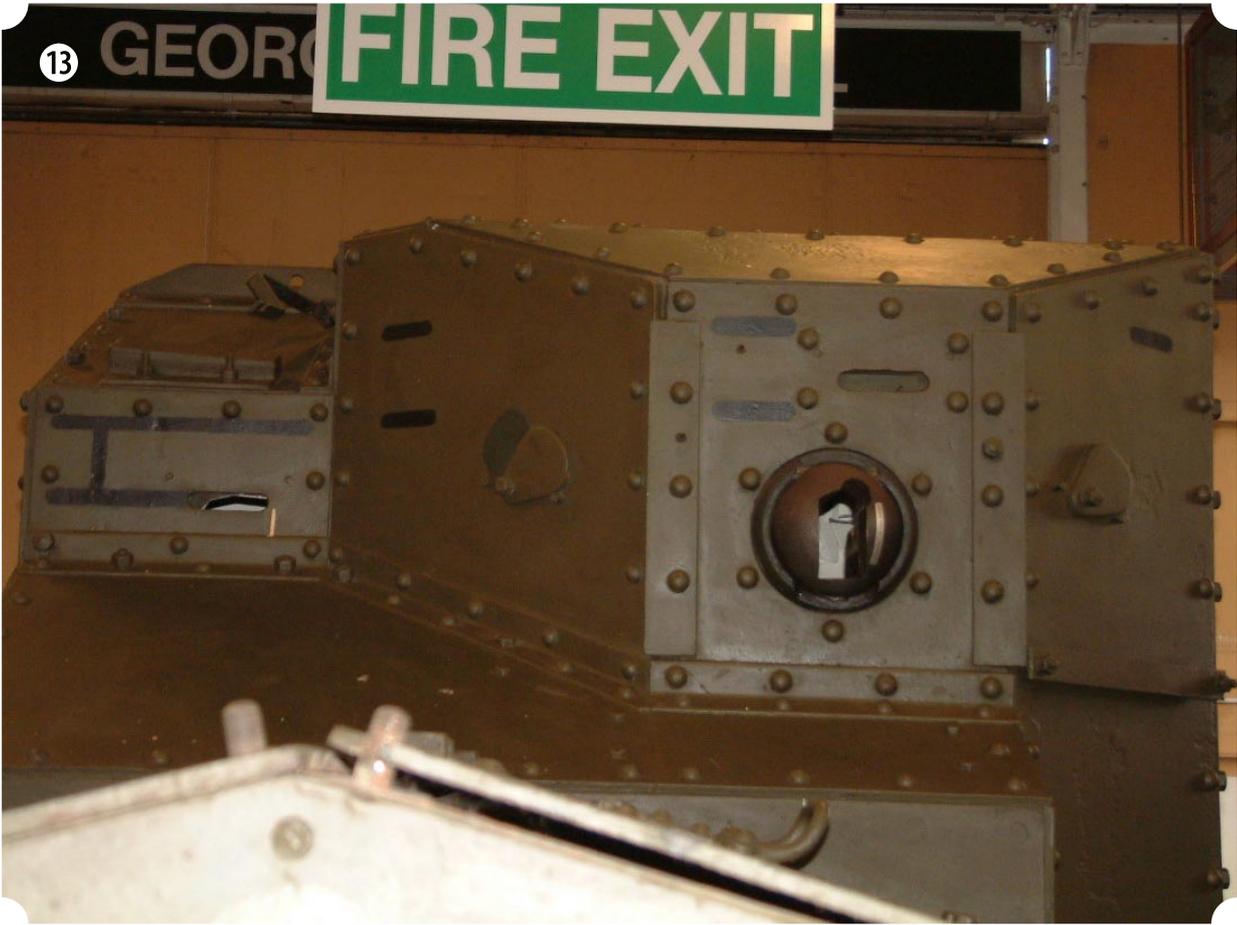
Front view

The unusual shape of the Whippet is clearly visible from this front view, with the track units (see pages 36 through 51) set onto the sides of the hull and the wedge-shaped armour plating around the fuel tank at the very front. The actual fuel tank is a simple, cylindrical drum made from sheet metal.

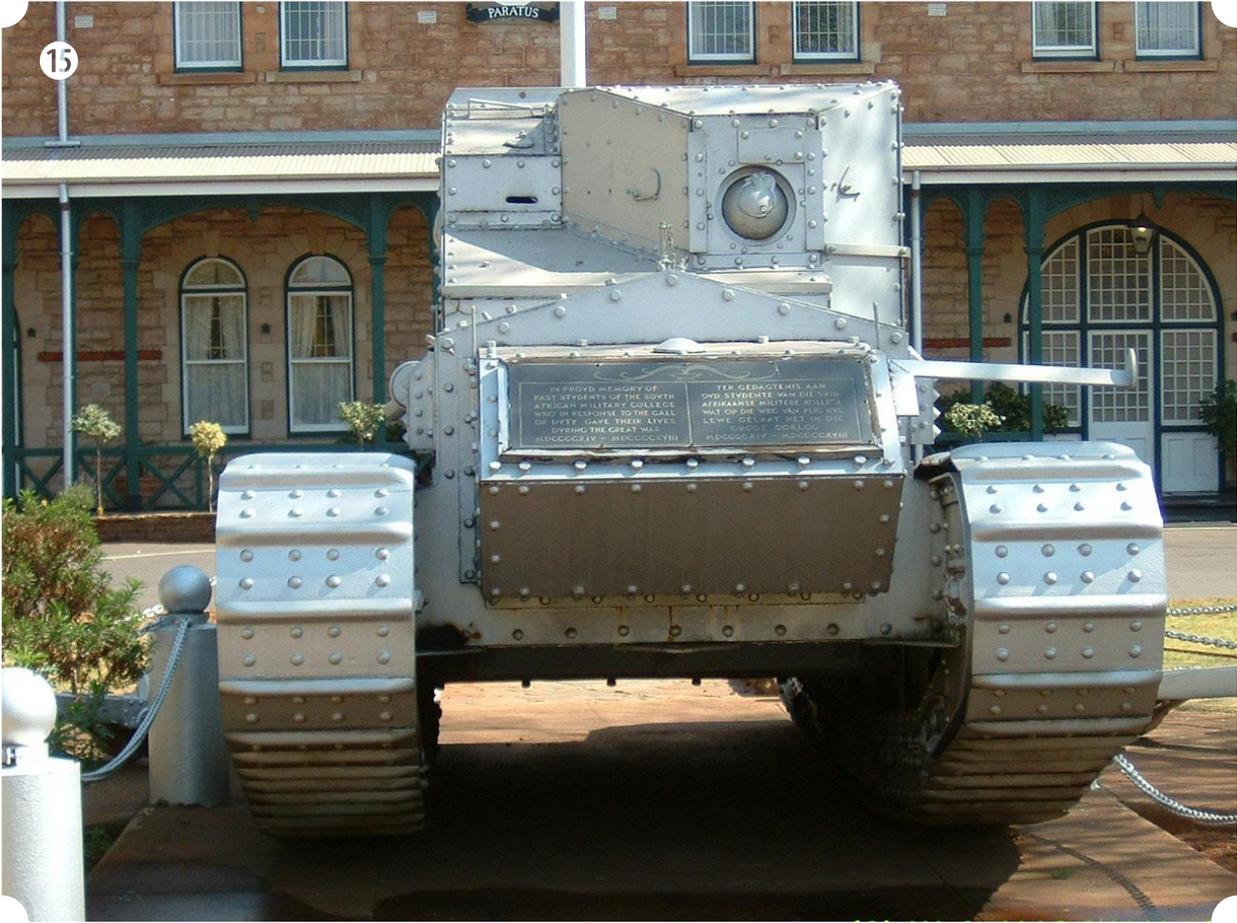
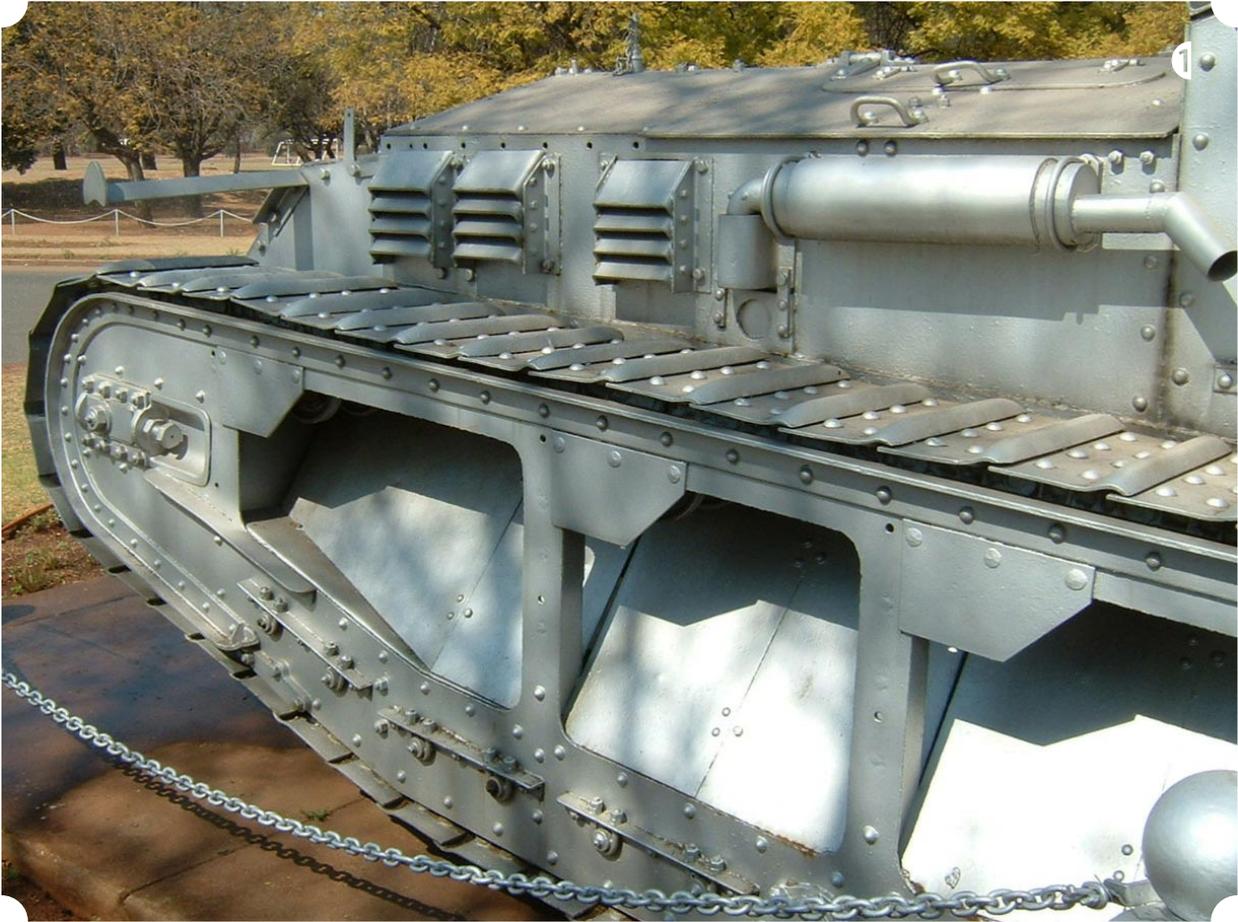
Engine deck left

The Whippet had two engines, one driving each track, and the large, hinged lid visible in this photo gives access to one of them. The smaller panel on it is probably for routine maintenance and servicing, or perhaps for additional cooling outside combat areas, as the left engine is directly underneath it.

The large panel is missing its handle, which can be seen on another Whippet in photograph 19 on page 24. The exhaust pipe is shown in more detail on pages 30 and 31.

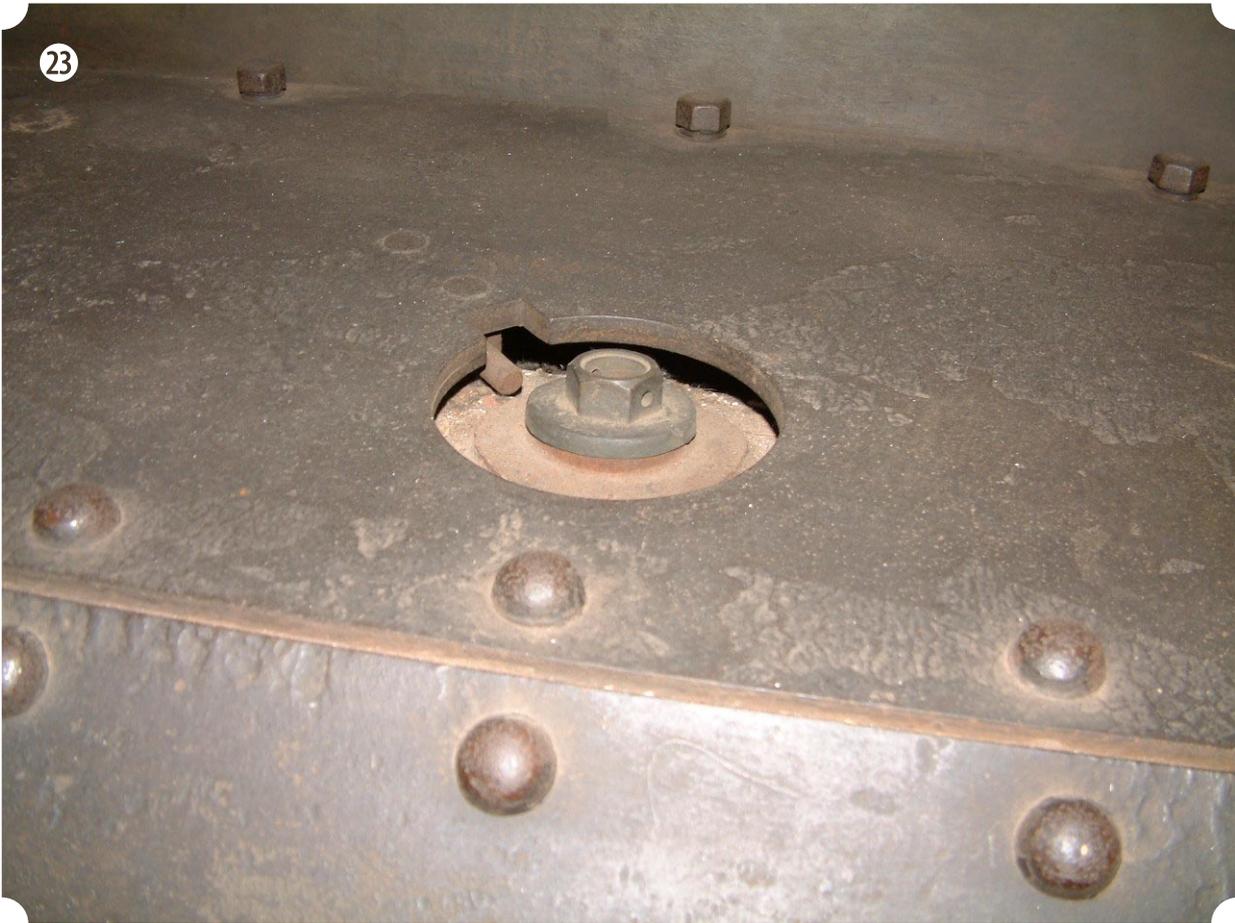
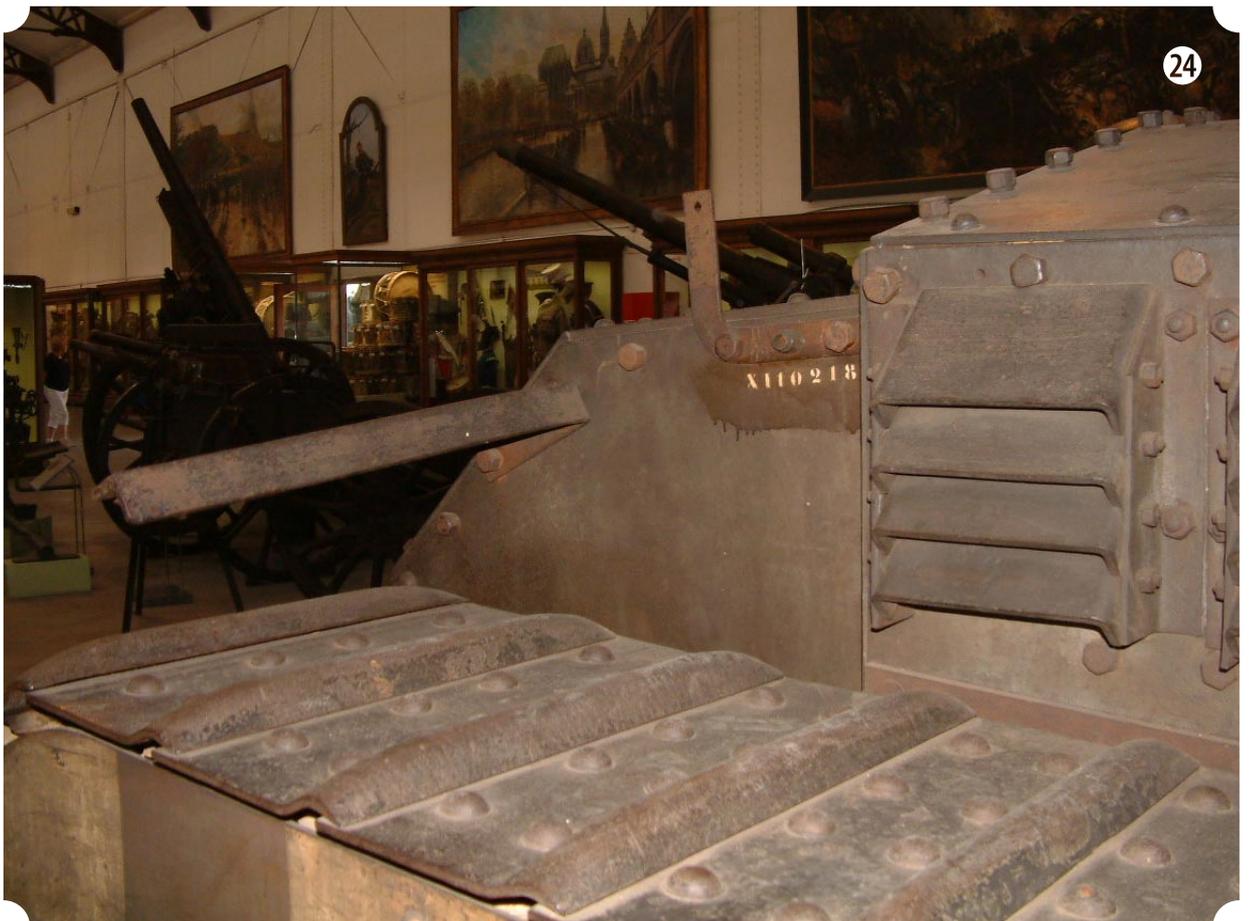
Exhaust pipe left

The same exhaust, but now on the Whippet in Brussels. This shows a sheet metal covering *over* the asbestos, which is missing on both exhaust pipes of the Bovington vehicle. Since the South African Whippet also seems to have such covers, it is perhaps safe to assume this is the way the tank was manufactured.

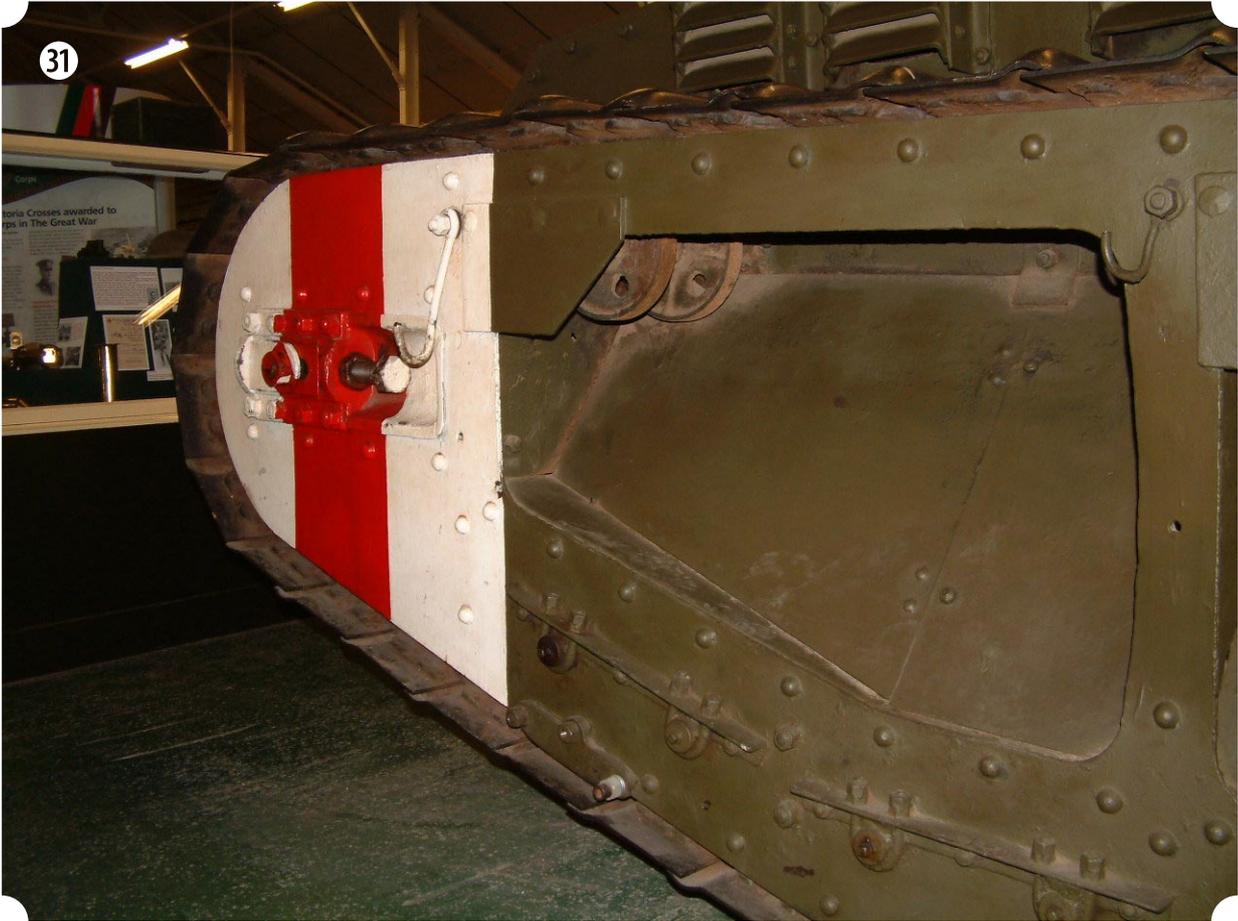
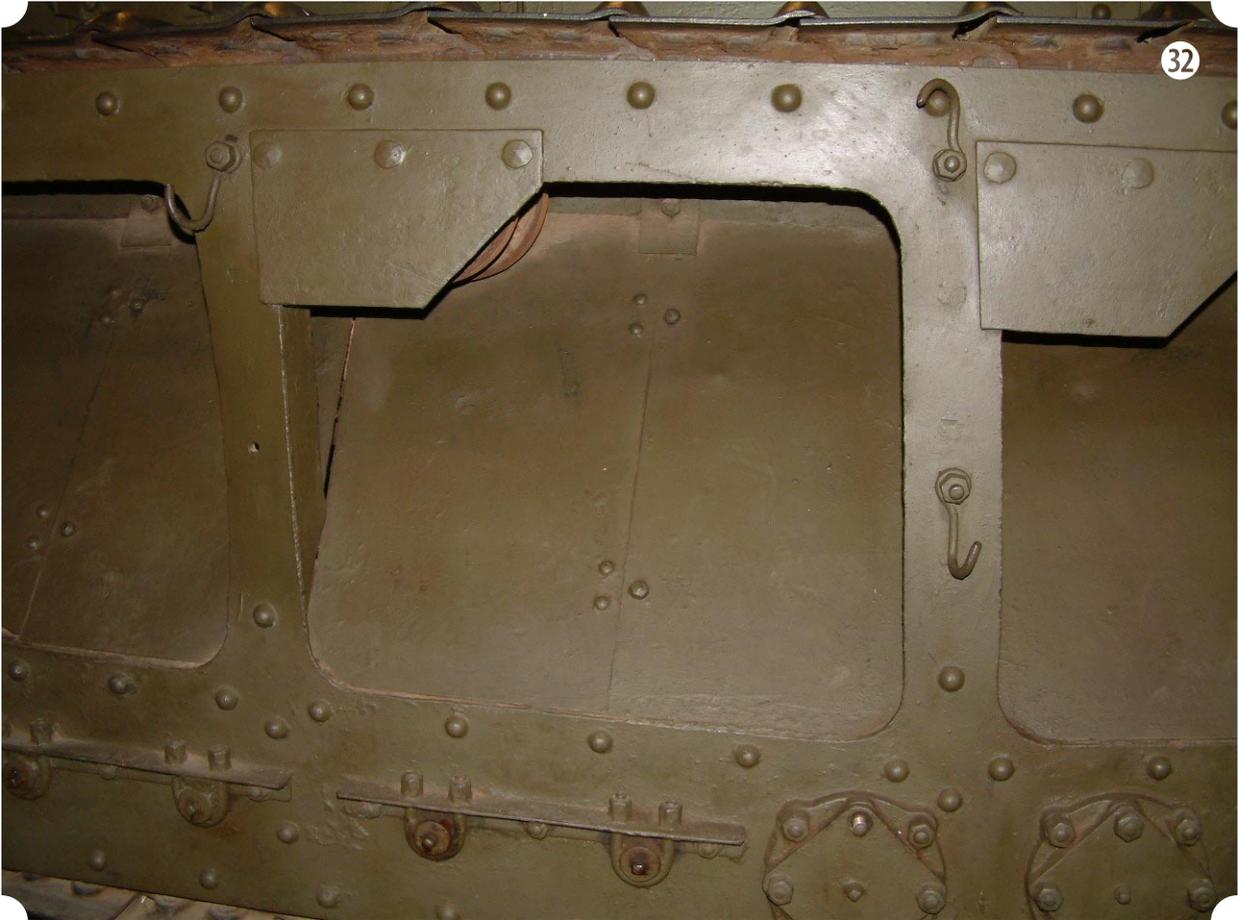
Track unit left

Inside the hole, the fifth return roller can be seen, as well as part of the chain that transfers power from the gearbox to the drive sprocket.
