Medium Tank Mark A

Whippet

Medium A Whippet

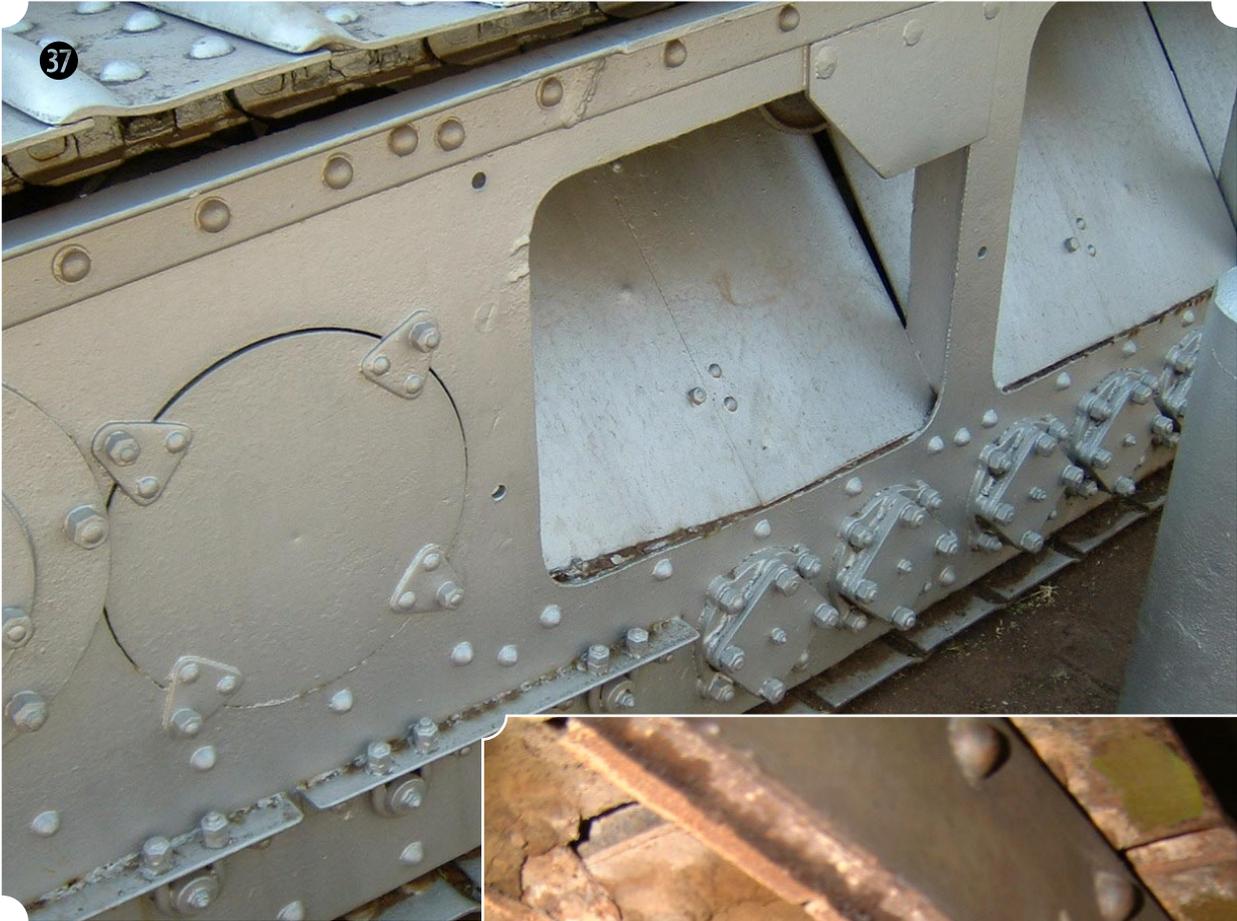
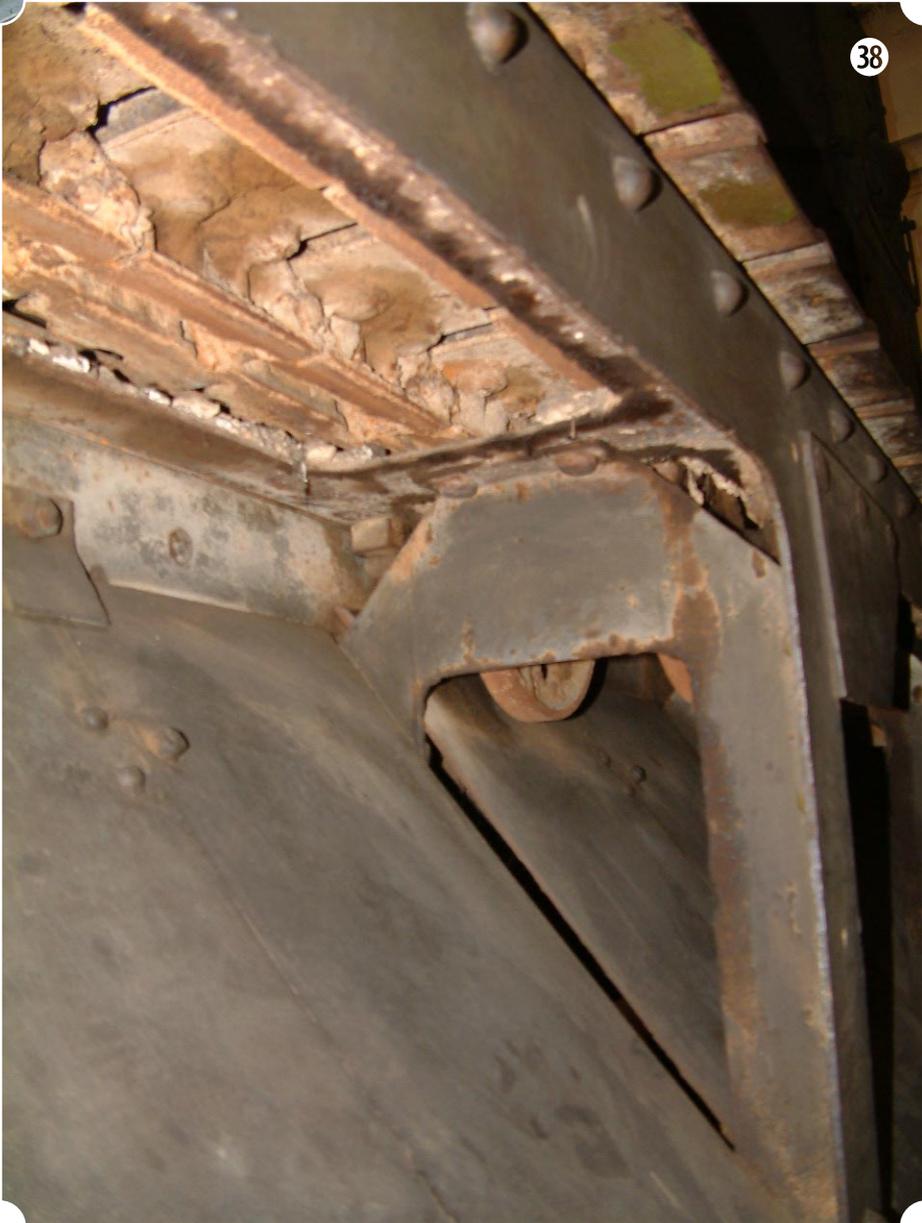
Underside left

The adjustment gear on the left track unit, seen from the rear looking forward. By loosening the nut on the side, the bolt in the recess can be turned forward to increase the track's tension.

The grease on the adjustment bolt and the fact that the washer and nut on the axle have obviously been turned since they were painted (and so has the adjustment bolt, if you look carefully at the white paint on it), together with the worn areas on the track chains (see page 49) lead to the conclusion that this Whippet had its left track worked on not very long before these pictures were taken.

An identical adjustment mechanism can be found on the insides of the track unit. To adjust the track tension, both adjustment mechanisms must be used, else the idler wheel would end up skewed.

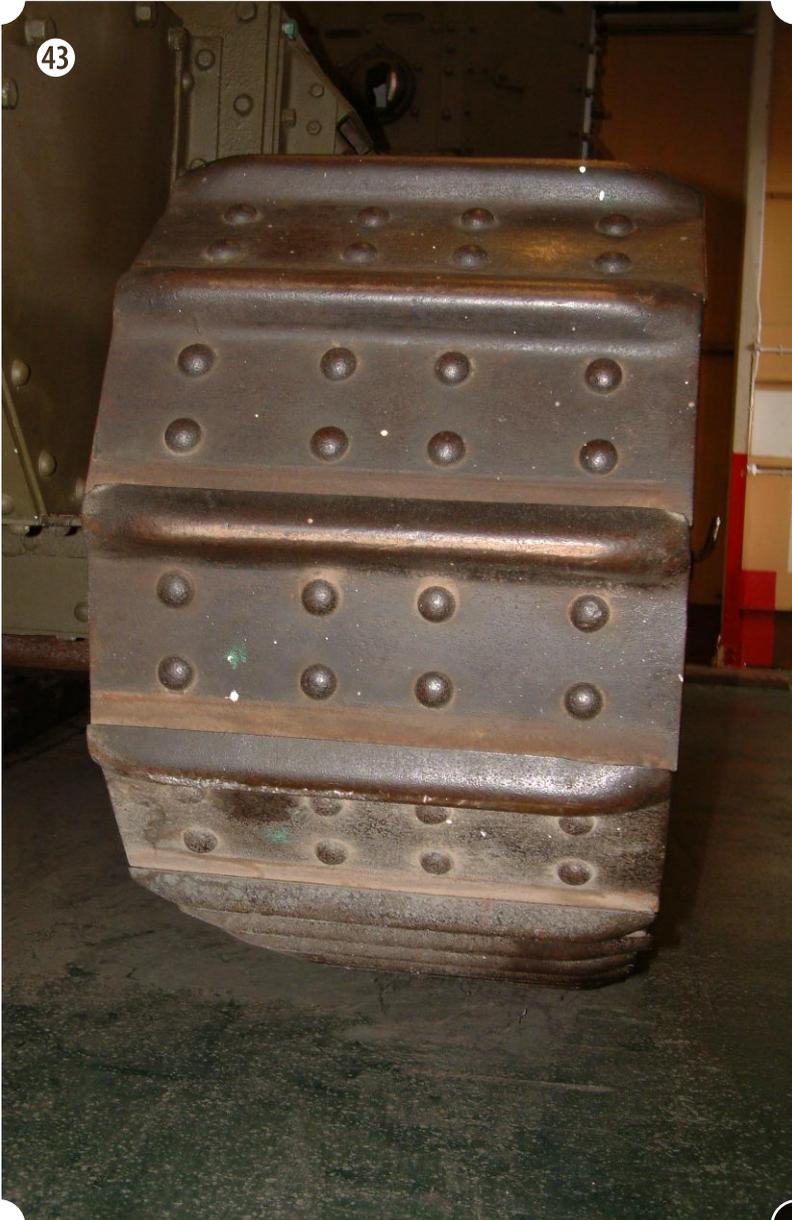
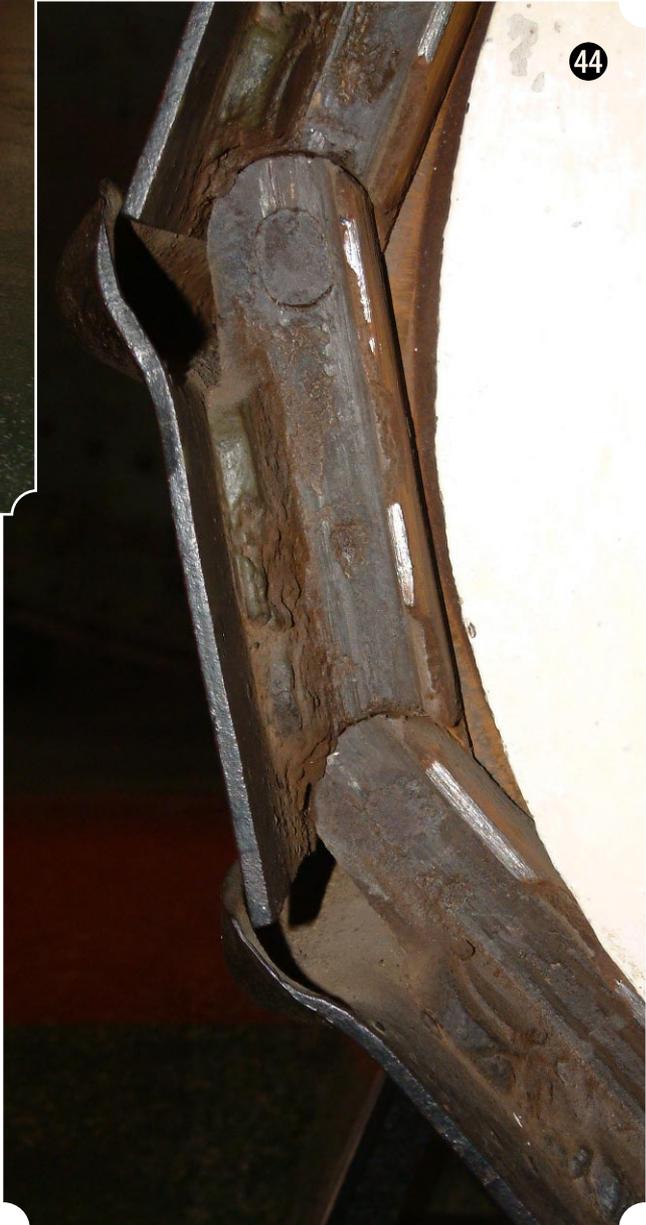
Track unit insides

On the inside of the rear part of the track unit is the final drive that transmits power to the drive sprockets at the rear of the tank. The sprocket visible in this photograph of the Brussels Whippet was at the front end of a chain which actually drove the wheel, but the chain itself has gone (picture 34 on page 39, of Bovington's vehicle, does give a glimpse of this chain). The sprocket is on an axle coming from the transmission below the floor of the cab rear, as can be seen on page 65.

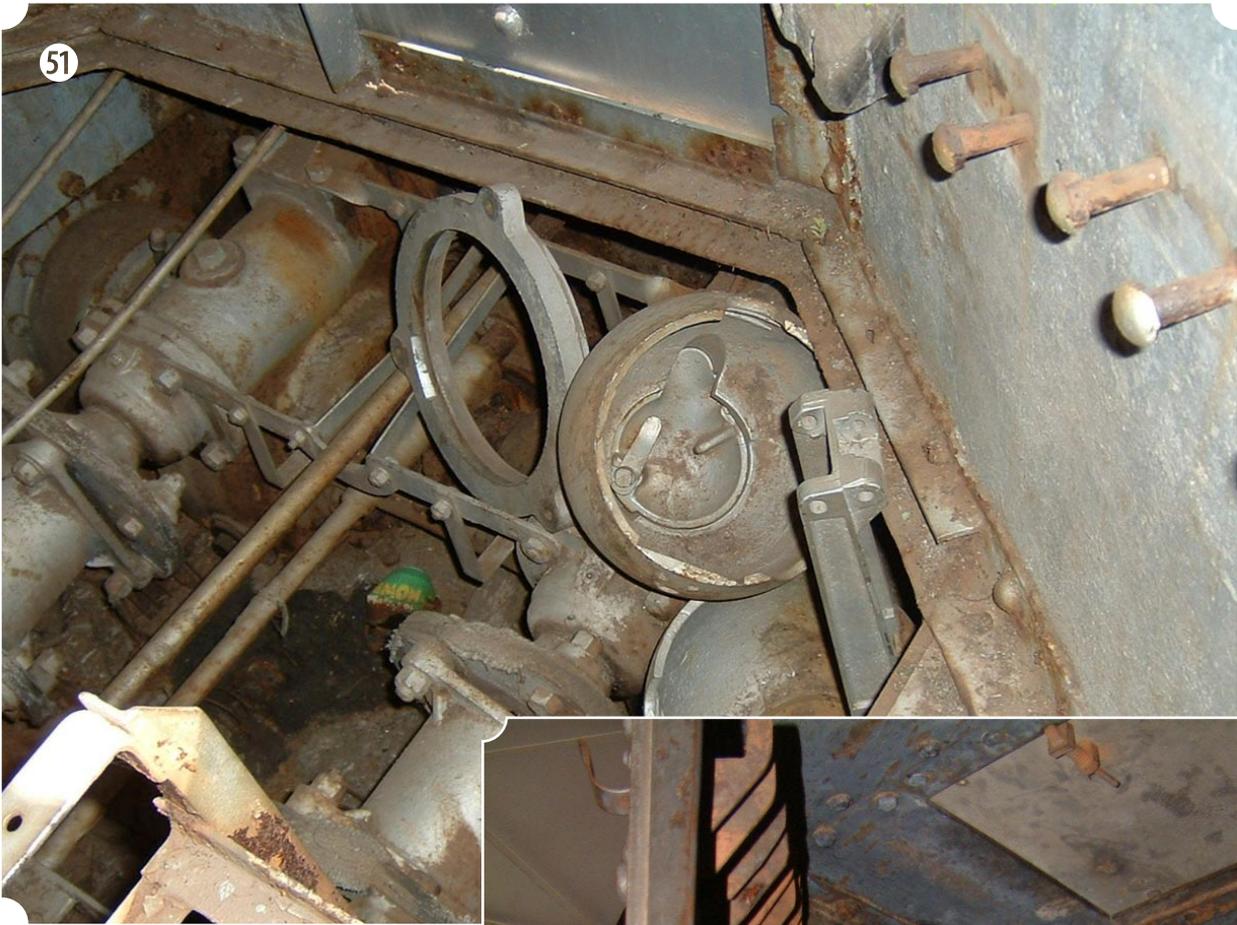
Cab left front

This photo is of much the same area as the previous one, but now from lower down and showing most of the cab's width. (And of a different tank, of course.) From this, it can be seen that another ammunition rack, for ten ammunition boxes, stood below the front machine gun mounting, obscuring the view of the engine that photo 53 provides.

The rectangular shape at the right of the picture is the back of the driver's seat.

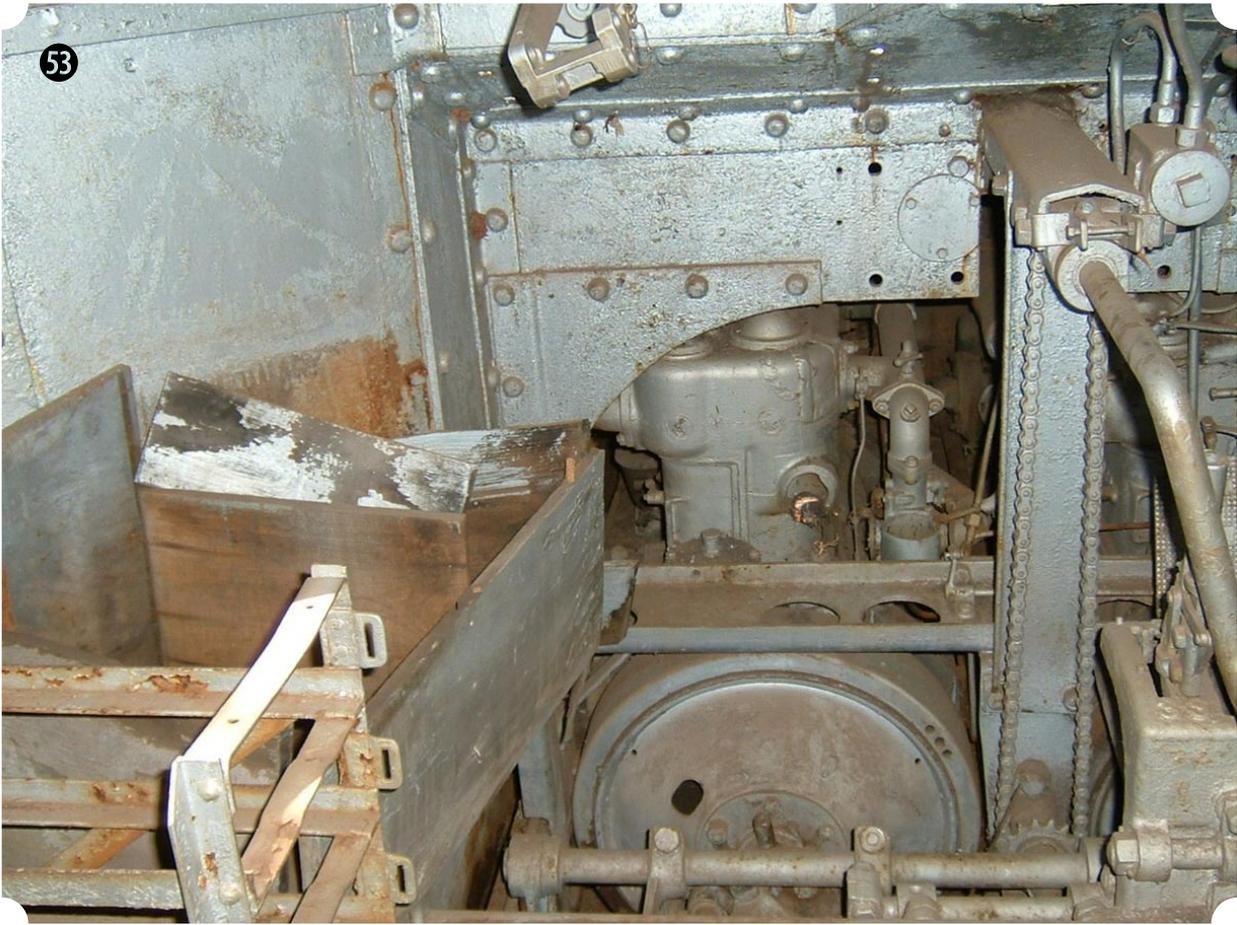
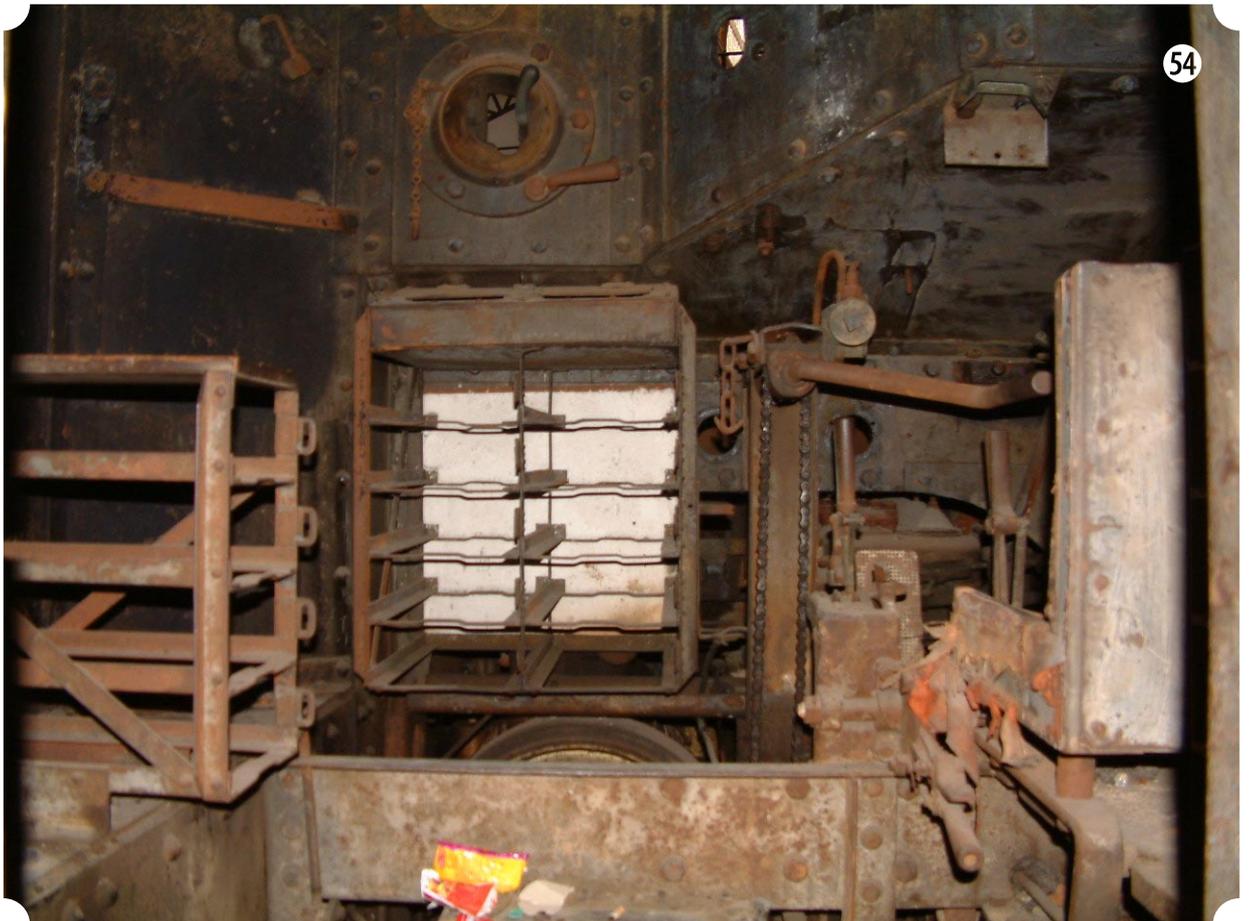
Driver's position

Though badly decayed over the years, the driver's seat is still there on the Brussels tank, however, the steering wheel is not.

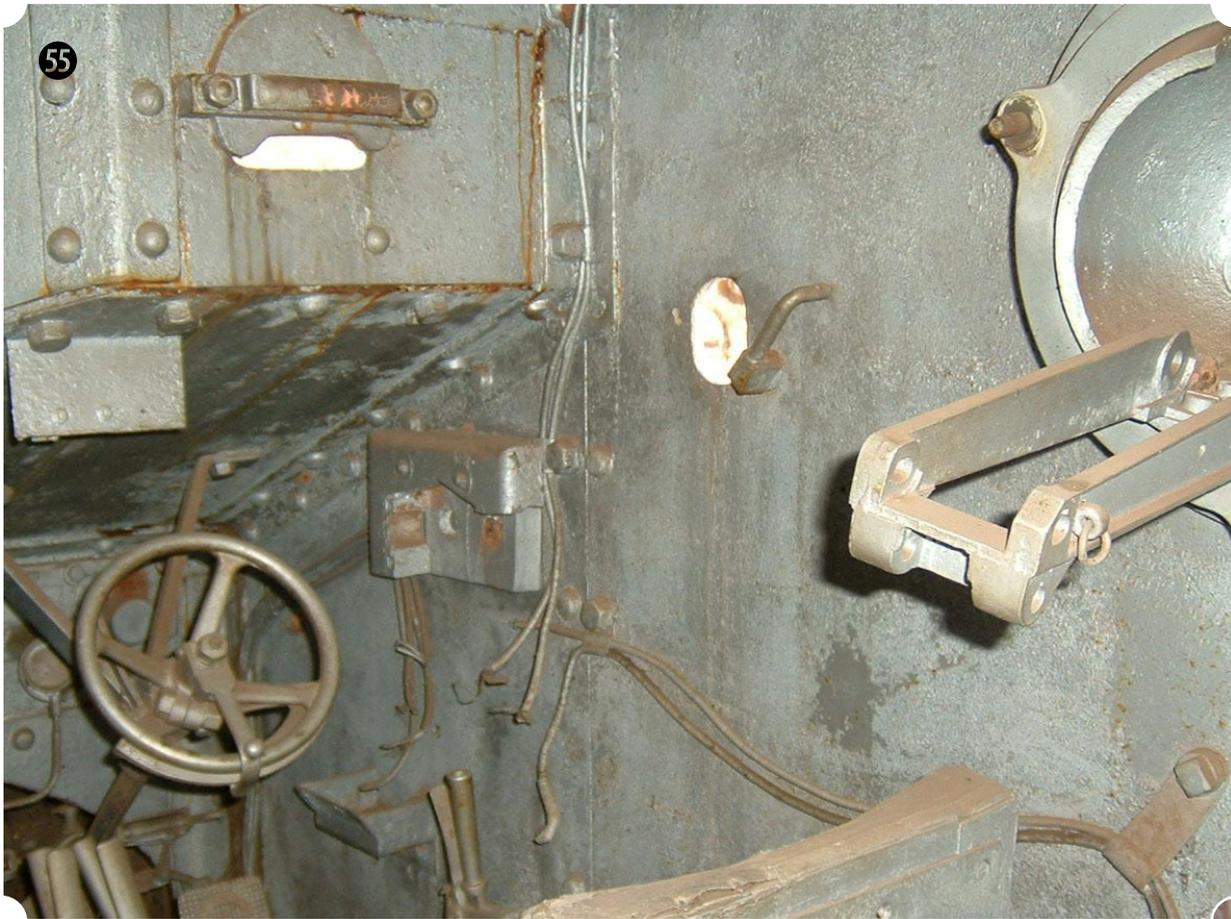
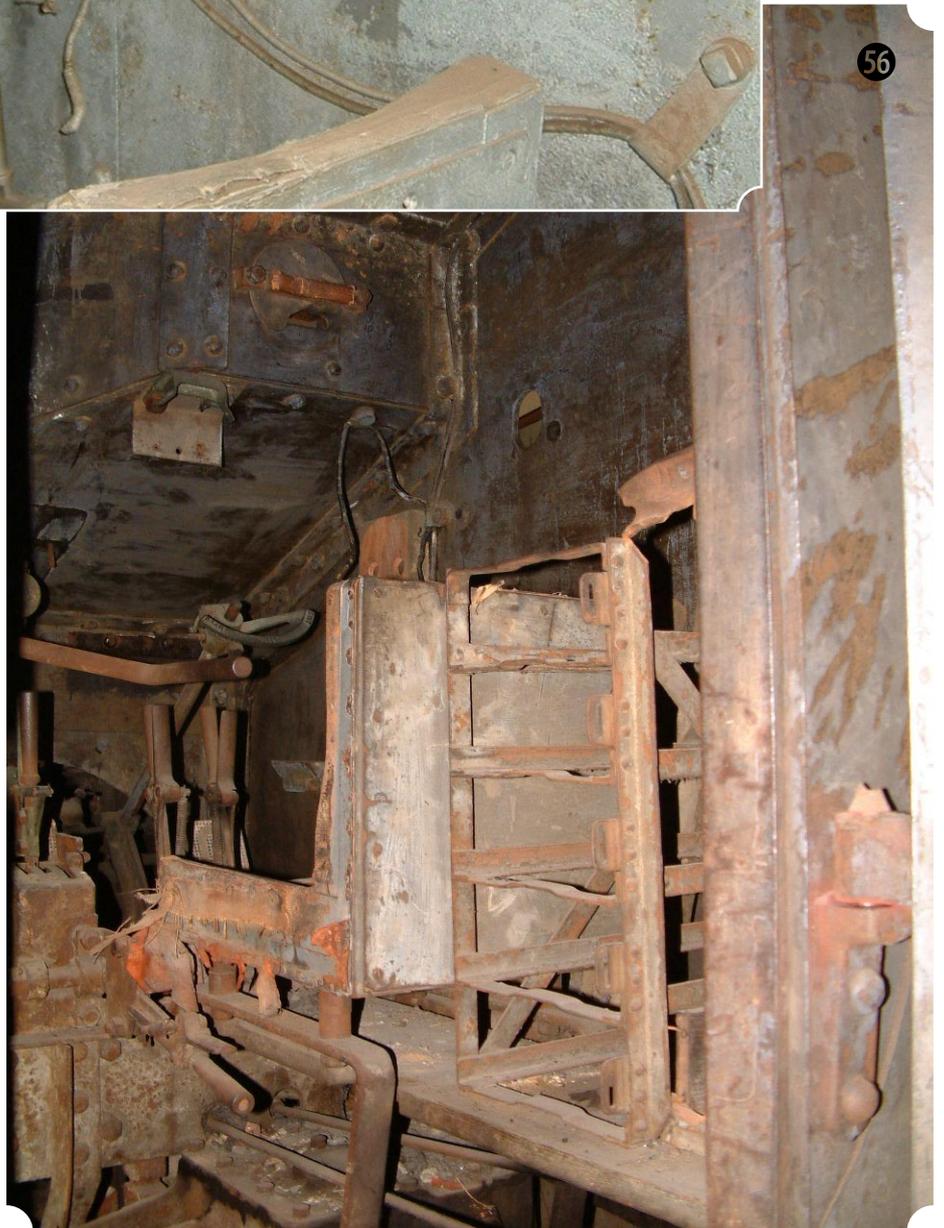
Behind the seat is another ammunition rack, this one for five ammunition boxes for the Hotchkiss guns.

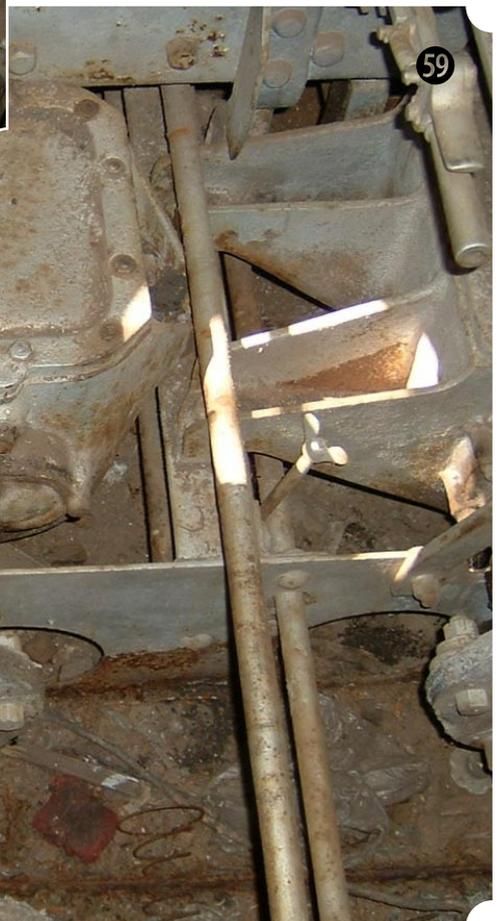
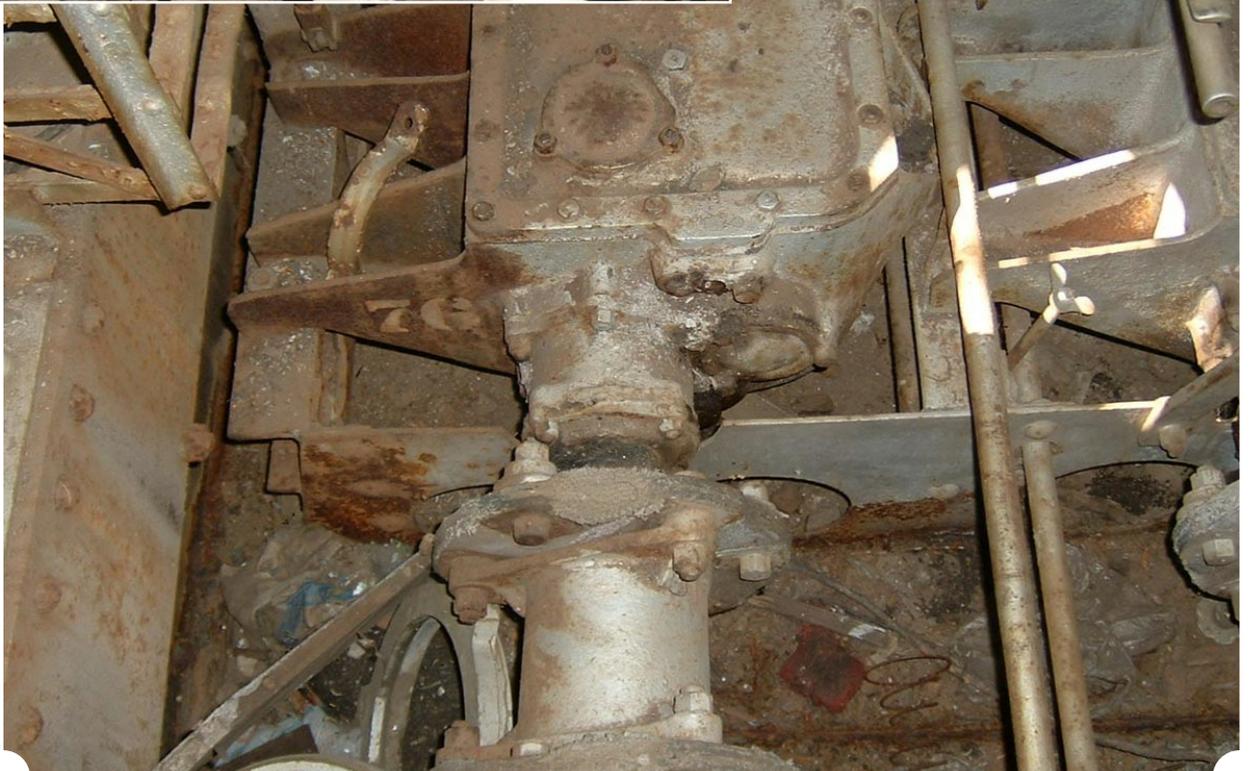
A view down from behind onto the left-hand transmission in the South African Whippet. The square part is roughly in the middle of the cab, length-wise, and is driven by the engine directly forward of it, just in front of the cab.

A second transmission is directly underneath the driver's seat, on the right of the tank.
