RSDYK

Dyke quality assessment by
remote sensing
and
geological information

Robert Hack

15 Oct 2009 Reeuwijk - Hack

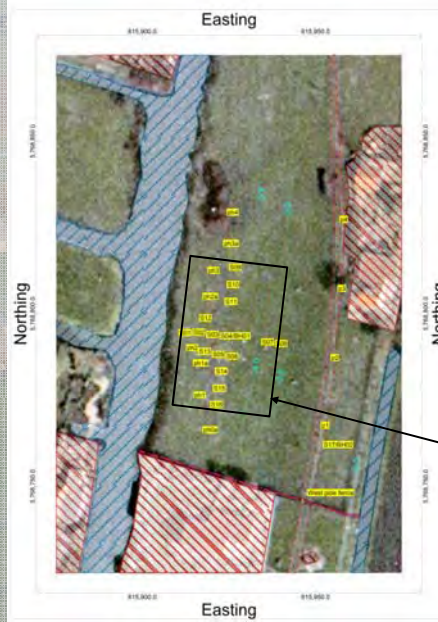
Tempeldijk-South

16 CPTs & 1 borehole in area of about 30 x 45 m²

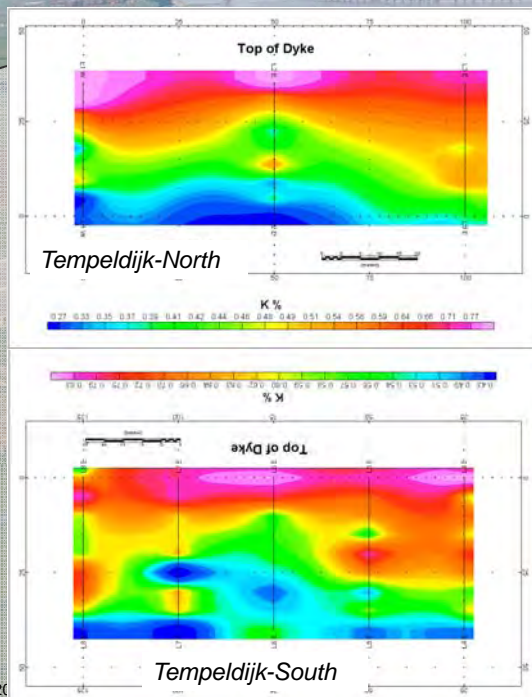
Gamma ray

- Tempeldijk-South, surface and subsurface structures are more irregular which are likely related to or indicate “problems” such as “kwel” and subsidence.
- Visual images showed differences in vegetation cover at locations where excess water is likely present.
- The gamma ray survey shows a pattern that is likely related to the real subsurface structure, but further investigations are required to determine the exact nature of this relation.
- Interpretation based on CPTs and boreholes show no irregularities
